INSPECTION REPORT

For the Property at:
1606 ANY DRIVE
MY VILLAGE, BC

Prepared for: ABC JHON
Inspection Date: Saturday, October 1, 2022
Prepared by: Gurtej Manj

RE: Report No. 1020, v.0
1606 Any Drive
My Village, BC

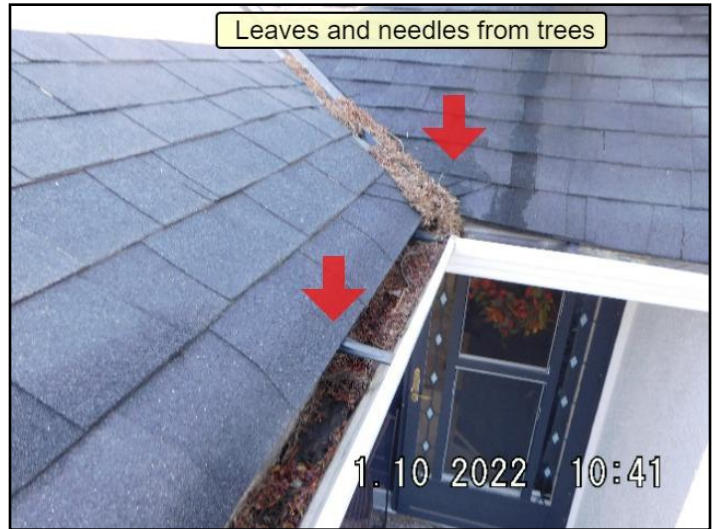
3. Condition: • [Clogged](#)

21. Clogged

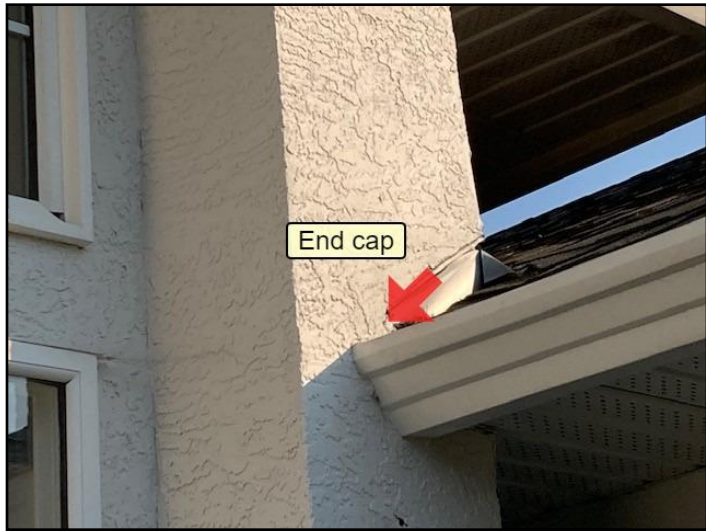
4. Condition: • Leak

End cap of the gutter is damaged

Implication(s): Chance of water damage to structure, finishes and contents

22. Leak

Task: Repair or replace by gutter installer

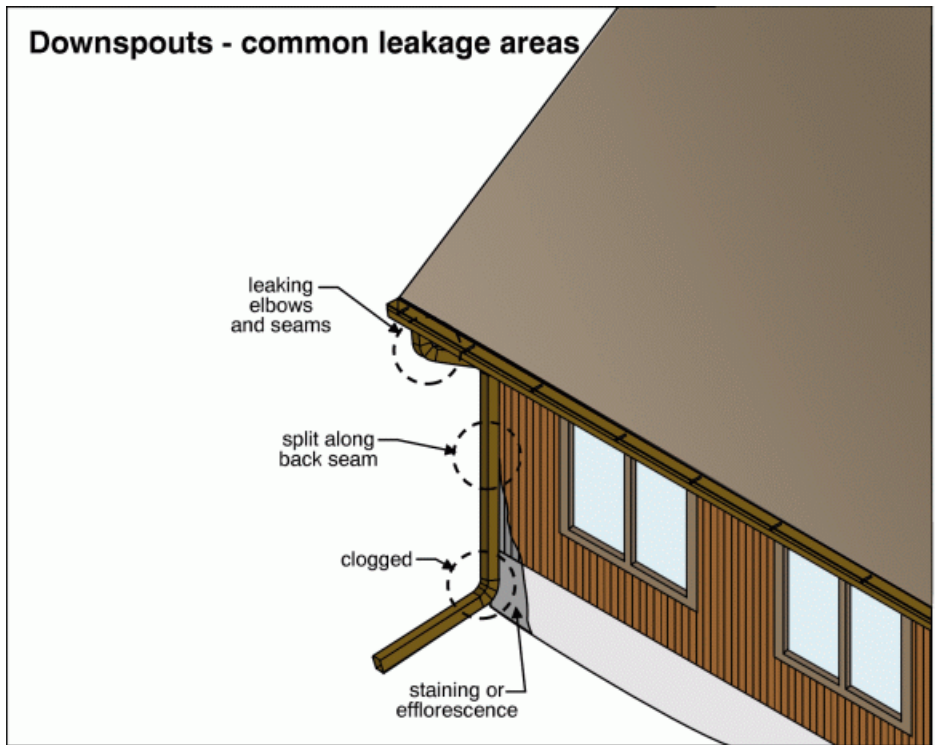
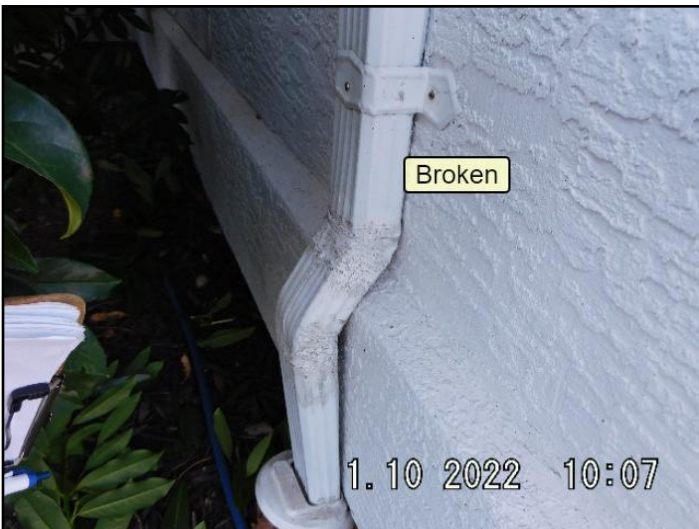
5. Condition: • [Leak](#)

The seam has opened ,the material has rusted through

Implication(s): Chance of water damage to structure, finishes and contents

23. Leak

Task: Repair or replace

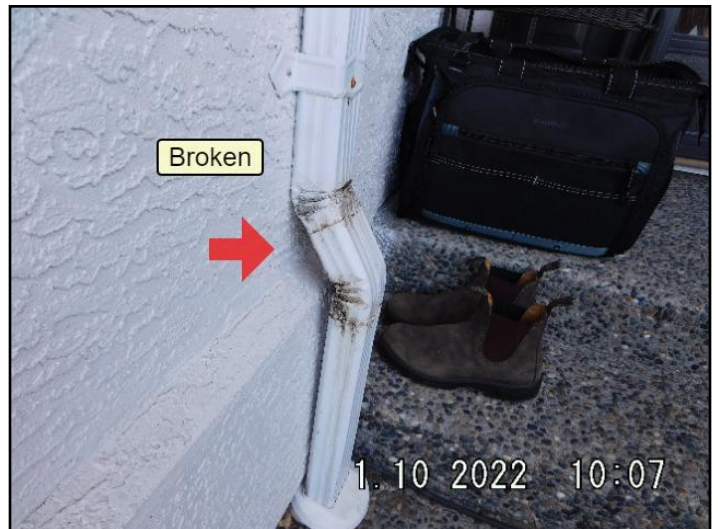
24. Leak

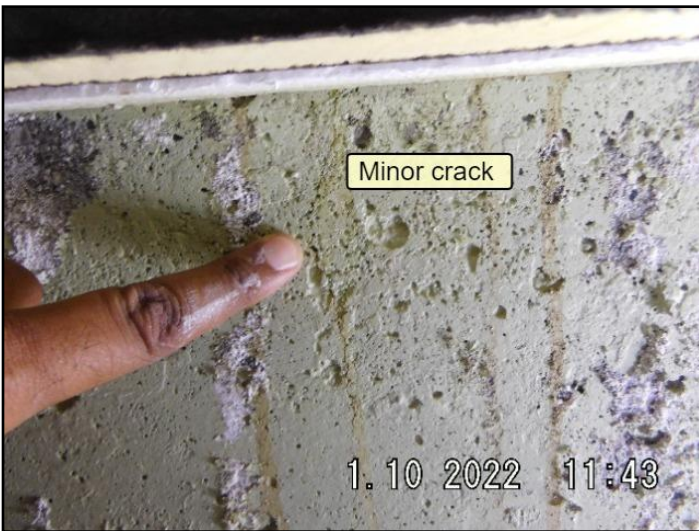
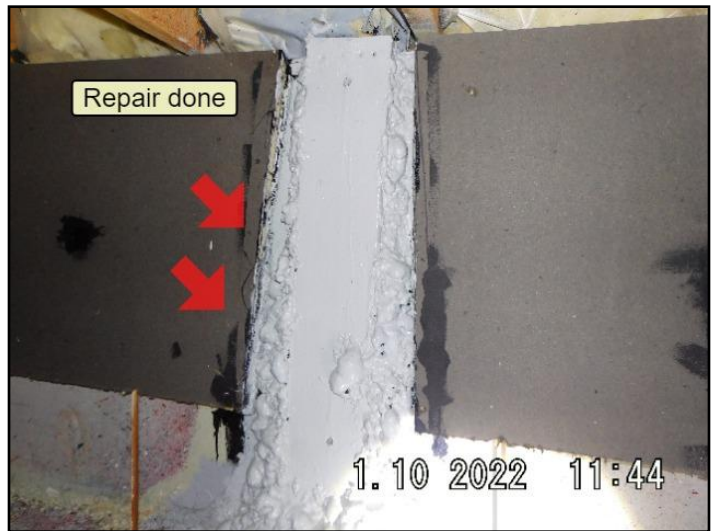
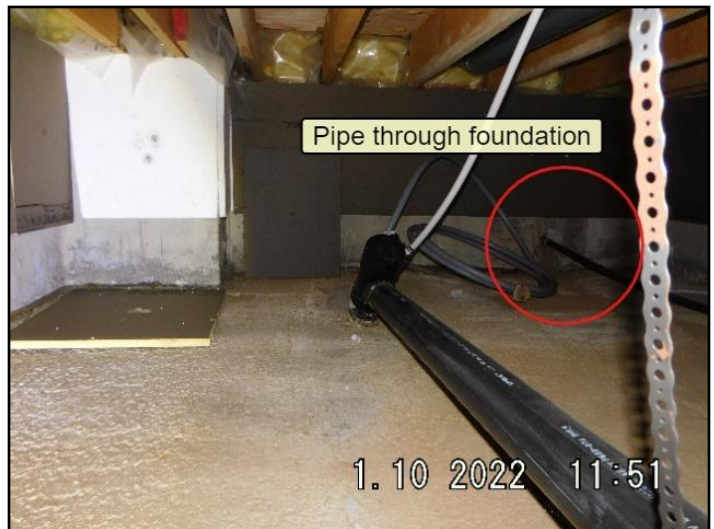
Condition: • In crawl space some of the patch work done on foundation and found minor cracks in foundation . Moisture penetration through the foundation back wall from outside because the water pond in the back yard . There was efflorescence on the foundation and floor (Moisture is the main cause of efflorescence) and cannot do the inspection that foundation wall from out side due to wood deck .Find out from owner about that patch work why they did it and who did it ?There was a black pipe through the front foundation wall need to be patched .

Implication(s): water leak may damage materials structure and may cause mould

Task: Further investigation by structural specialist to determine cause and scope of work

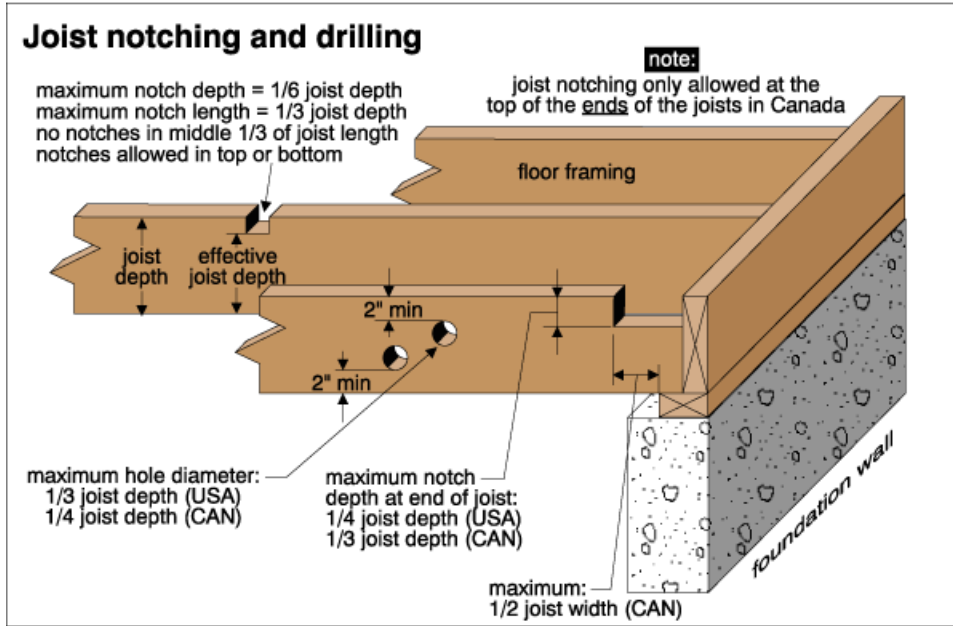
11. Condition: • [Notches or holes](#)

41. Notches or holes

Task: Further evaluation by structural specialist to determine scope of work and cost

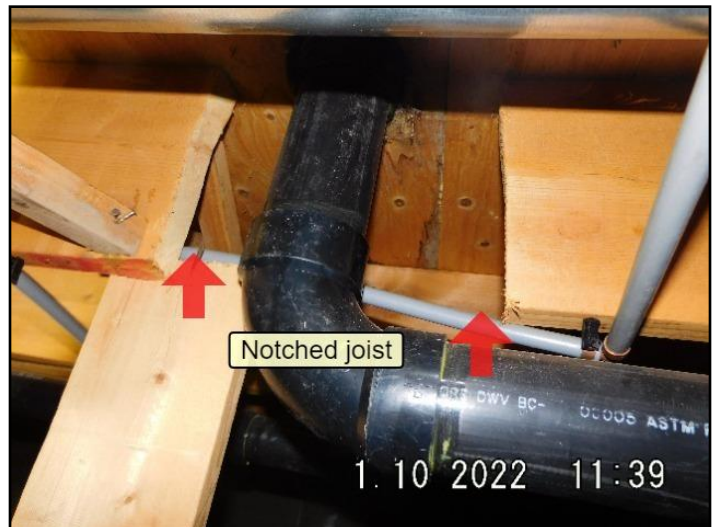
42. Notches or holes

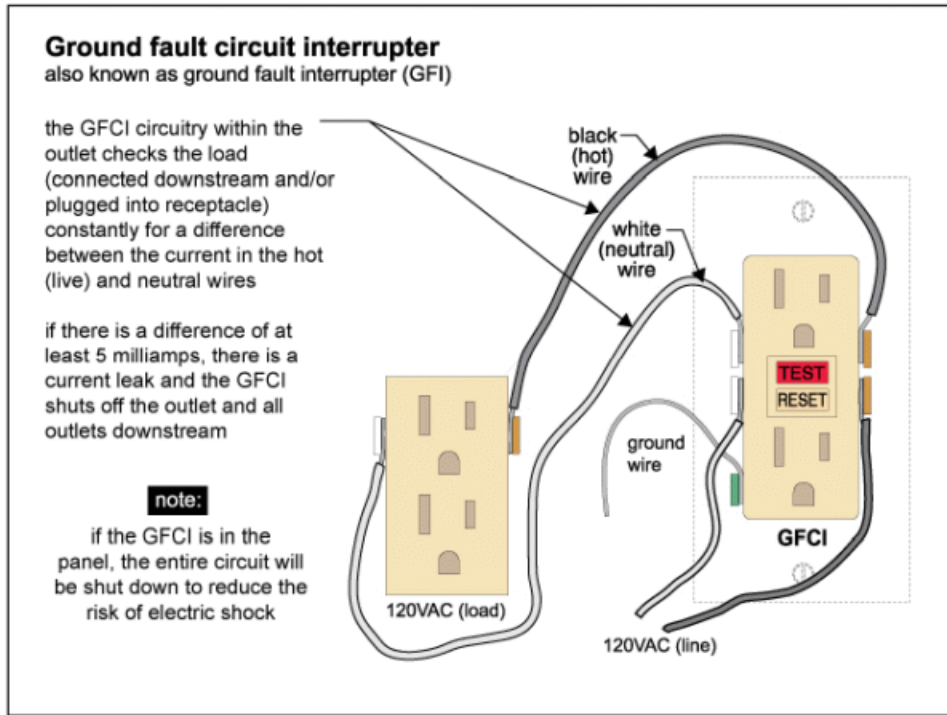
DISTRIBUTION SYSTEM \ GFCI (Ground Fault Circuit Interrupter) protection not noted at

57. Kitchen counters

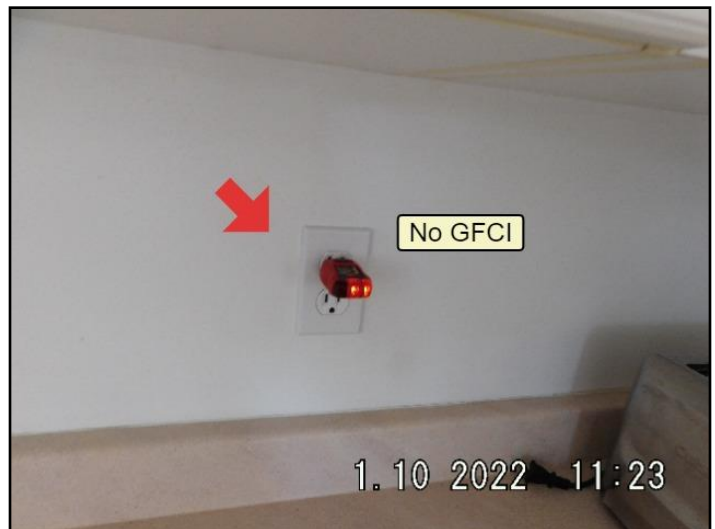
58. Kitchen counters

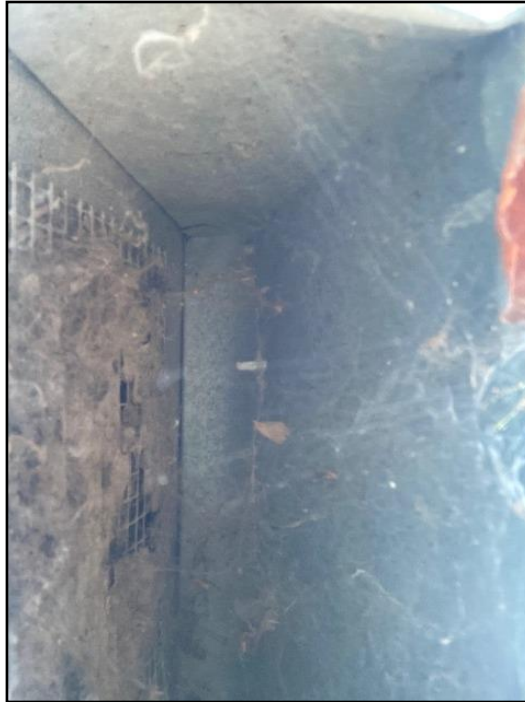
68. fresh air intake clogged

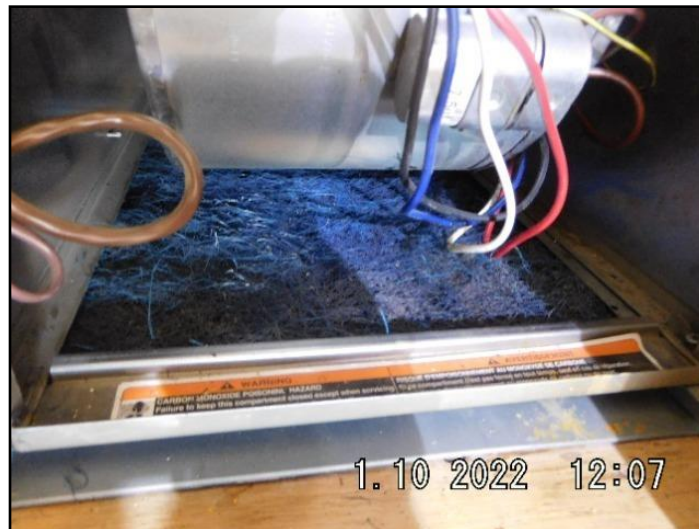
72. Dirty

Task: : Replace disposable filter

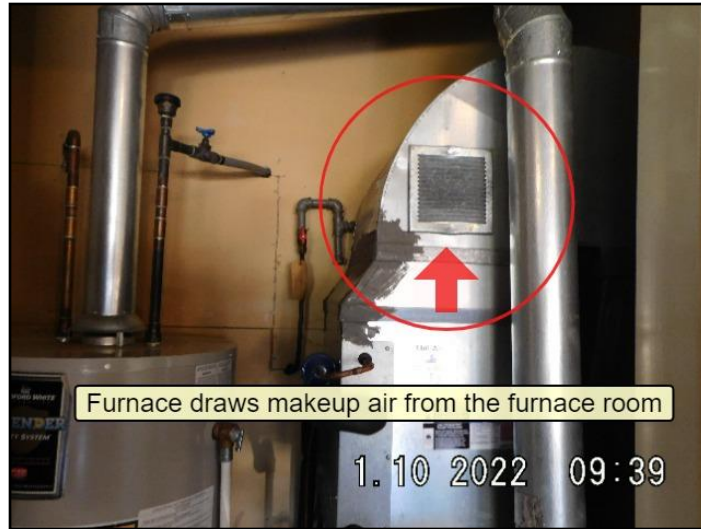
73. Inadequate combustion air

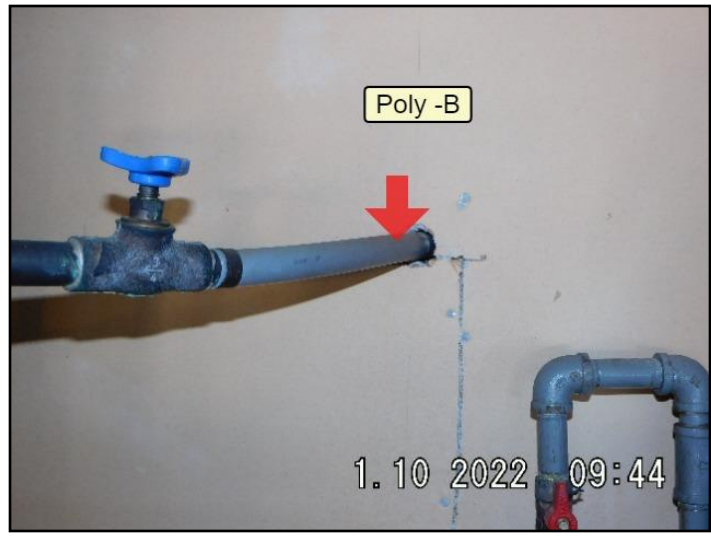
This home is plumbed, in part or in whole, with Poly B (Polybutylene) piping. Poly B was manufactured and installed in homes in North America from the late 70's to the mid 90's. Many homes have experienced no problems; however, Poly B has a higher-than-normal failure rate. Plastic fittings were the most problematic. Canadian installers used primarily copper and brass fittings and elbows, which alleviated many of the problems. The visible Poly B in this home uses copper or brass fittings, and no leaks were noted at the time of inspection. Contributing factors for failure are water pressure in excess of 60 PSI, hot water temperatures of over 130F, high chlorine levels, when used in a hot water circulation loop, it may corrode, and it should never be connected directly to a hot water heater, nor exposed to sunlight. Your insurer may want to know if the fittings are copper. Investigate your insurers' position on homes with Poly B plumbing as policies and deductibles can differ dramatically and some may require complete replacement. There are many websites that provide information on Poly B piping, and you are encouraged to do some research. Focus on Canadian sites.

Implication(s): : Chance of water damage to structure, finishes and contents | Leakage

93. Poly- B

Task: Discuss with insurance company. Consult a lic. plumber regarding the condition of the piping.

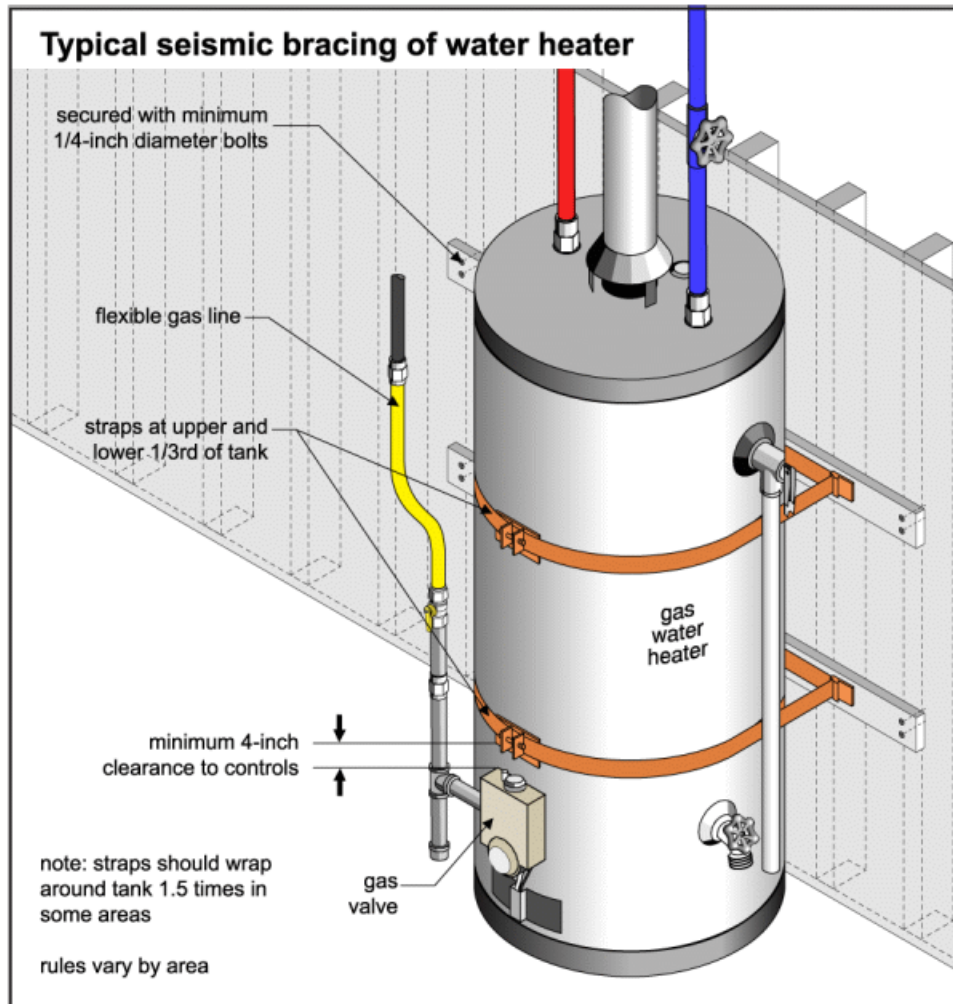
27. Condition: • There is an absence of seismic strapping retaining the hot water tank. Seismic bracing is usually required for water heaters to ensure that they do not fall over in the event of a seismic event. With gas heaters, this can present a fire and life safety hazard.

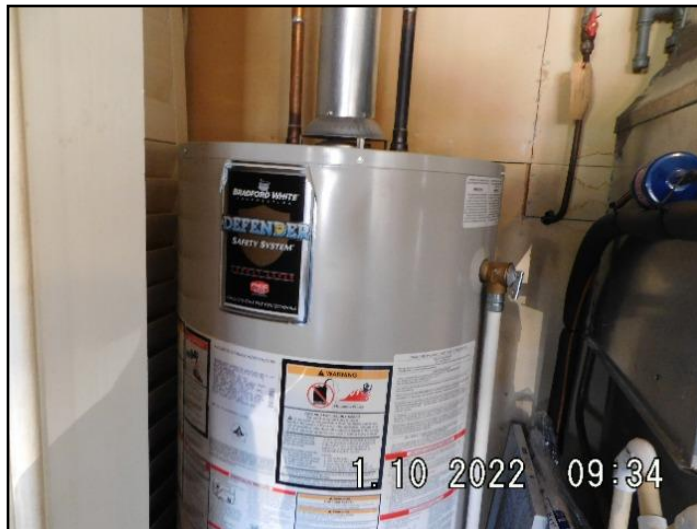
Hot water tank is about 9 year old and life expectancy is about 8 to 10 years. One cannot predict with certainty when replacement will become necessary due to failure. However for tanks that are 10 years of age or older most insurance companies require replacement. Check with you home insurer as to their policies regarding tank age and replacement requirements. It is most likely that your insurer will require the tank to be replaced if it is 10 years old or older.

28. Condition: • [Near end of life expectancy](#)

94. Near end of life expectancy

Task: Insurance issue ,Engage a plumber for quote (budget for replace)

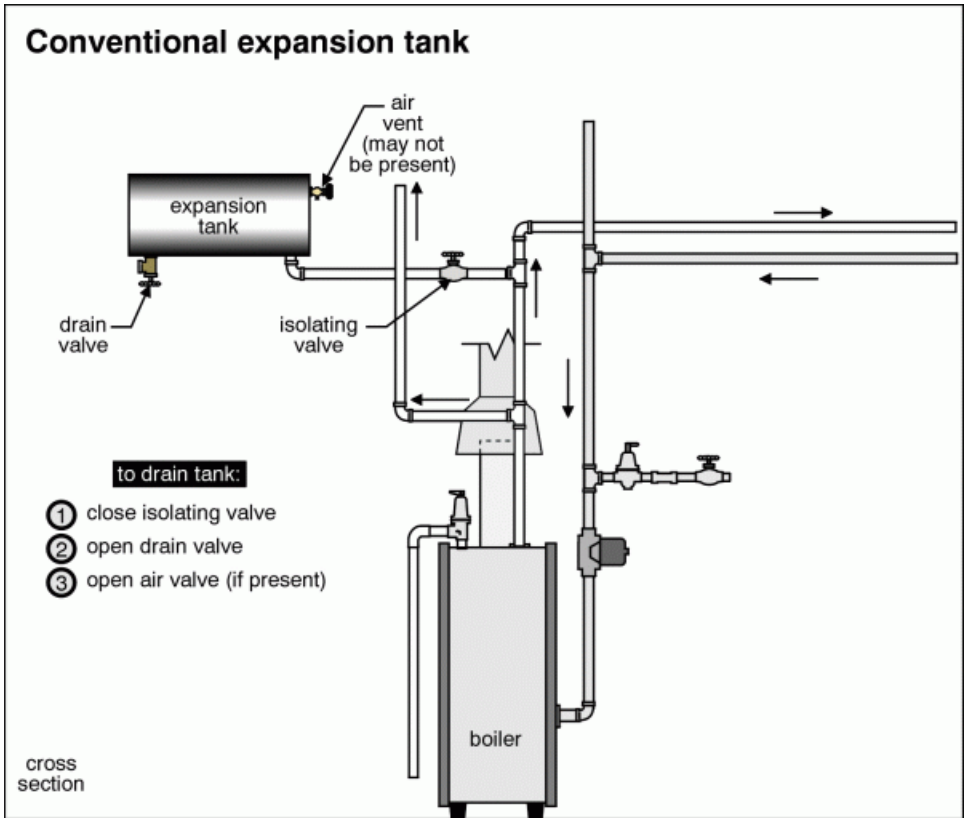
29. Condition: • No expansion tank has been installed on this system. The expansion tank is designed to handle the thermal expansion of water as it heats up in the water heater, preventing excessive water pressure. If water pressure gets too high it can damage valves in plumbing fixtures, joints in supply pipes and the water heater itself. As an alternative a Thermal Expansion Relief Valve (TERV) can be installed. Note this is different than the Temperature Pressure Relief Valve (TPRV) already installed on your hot water tank. Recommend having a licensed HVAC contractor install an expansion tank or TERV when the hot water tank is replaced

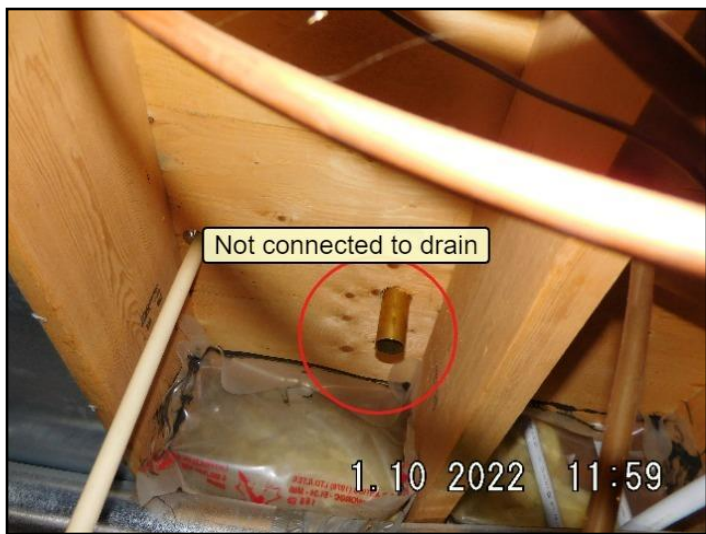
95.

30. Condition: • Drip pan under hot water tank is not connected to drain
Implication(s): Chance of water damage to structure, finishes and contents |
Location: Crawl space
Task: Engage a plumber for quote and scope of work
Time: upon possession

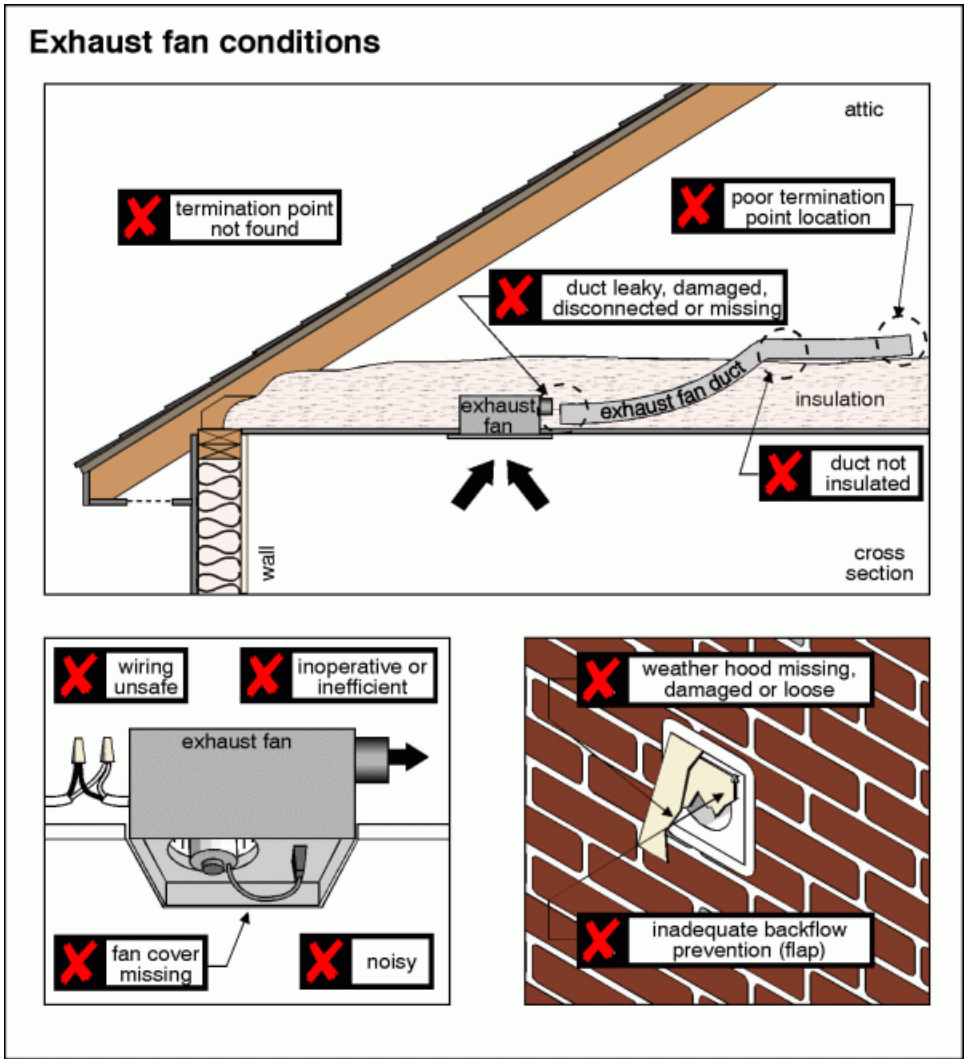
Implication(s): Fire and life safety hazard

34. Condition: • Range hood discharges to the soffits and The flexible metal type of vent connector has the advantage of being quick and easy to install. The disadvantages are that it restricts the air flow within the vent and the interior ridges can trap grease (oil) leading to a potential fire hazard and air exhausted through the soffit will likely be sucked back into the attic through the soffit vents . The condition is mitigated by the short run before the vent connects to the ceiling.
