# Your Inspection Report

10-110000 45 AVE  
My Village, BC

Wednesday, June 5, 2024

RE: Report No. 1073, v.0  
10-110000 45 AVE  
My Village, BC

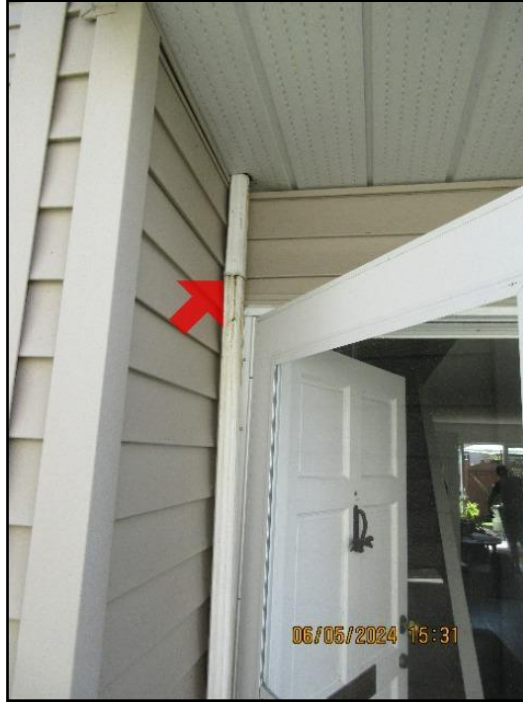
13. Damage downspouts

**3. Condition:** • The gutters and downspouts require repairs to ensure reliable performance. Gutter and downspout systems are critical for controlling roof runoff and preventing water from damaging the building. These gutters and downspouts are old and close to the end of their useful service life. Have this important drainage system further evaluated by a qualified party and repaired or updated as recommended. If repairs are made, funds should be reserved for updating the gutters and downspouts in the near term. Examples of specific observations noted during inspection include:

Check with strata who will be responsible for downspouts repair.

**Implication(s):** : Chance of water damage to structure, finishes and contents | Leakage

**Task:** Repair or replace by gutter installer

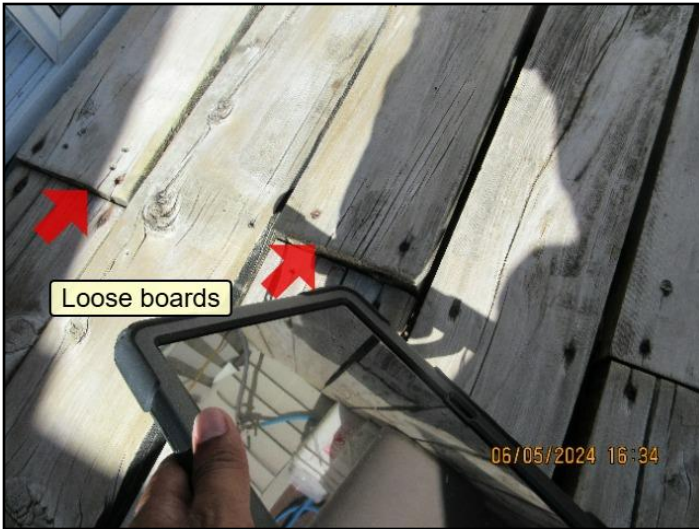
14. Rot /loose boards

### 4. Condition: • [Rot](#)

The softwood decking on this deck is at the end of its useful service life. The decking is rotting and in poor condition. Temporary repairs can be made by replacing the worst boards, re-setting loose nails and cleaning and re-staining the wood but this deck needs to be re-decked in the near term. The structure should be fully evaluated by a qualified general contractor prior to re-decking. Even treated wood will eventually decay and older decks are seldom built to today's standards. This can make complete deck re-building a better option than just re-decking.

**Task:** Repair or replace by carpenter

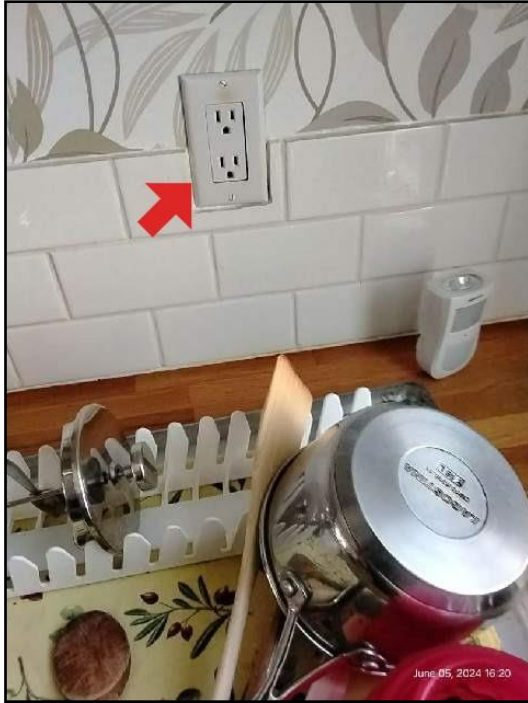
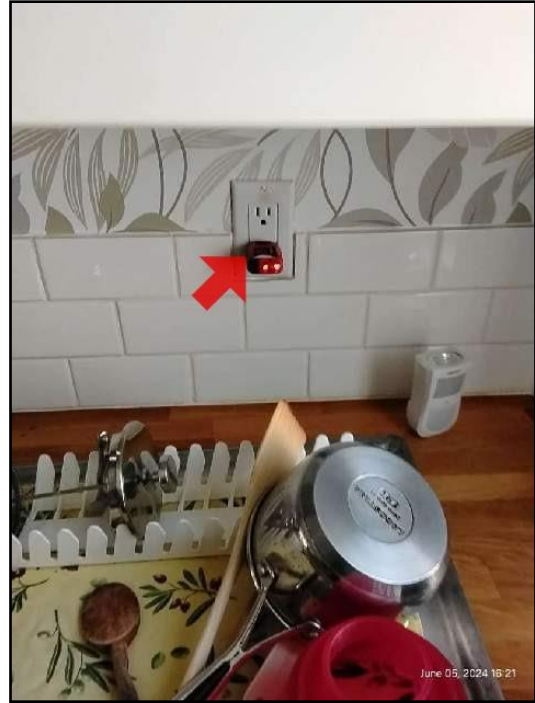
20. No GFCI in kitchen

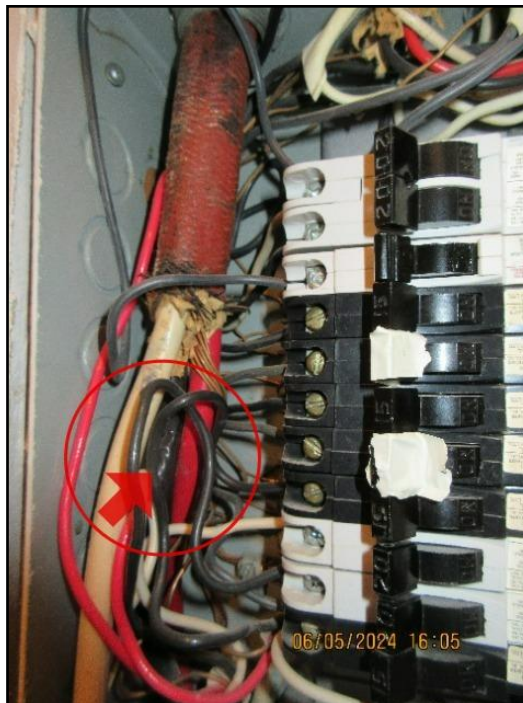
28. Not well secured

**6. Condition:** • [Not well secured](#)

Noted unsecured wire in electric panel during inspection

**Implication(s):** Electric shock | Fire hazard

**Task:** Repair by licensed electrical contractor

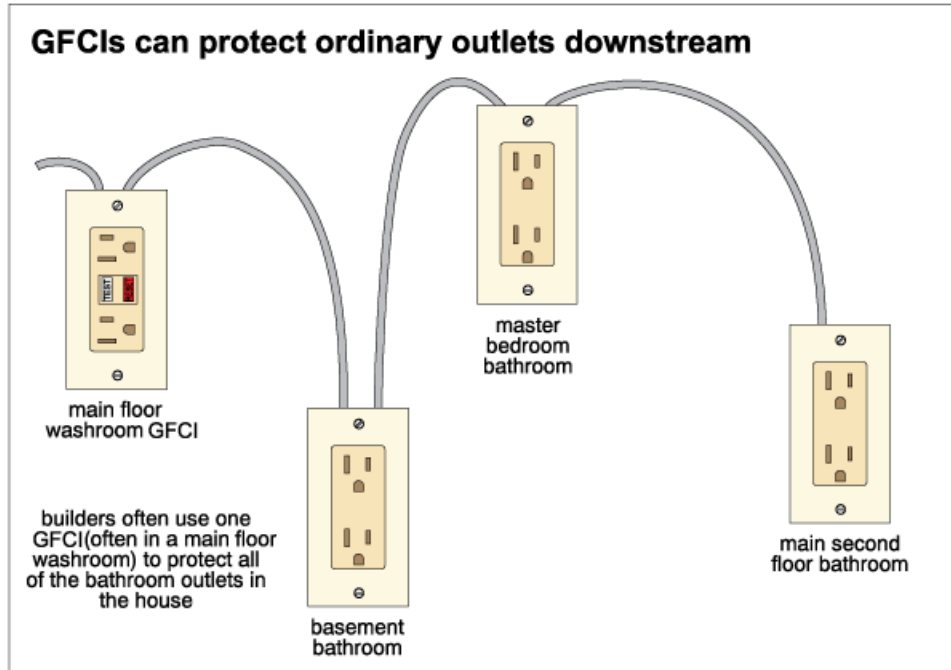
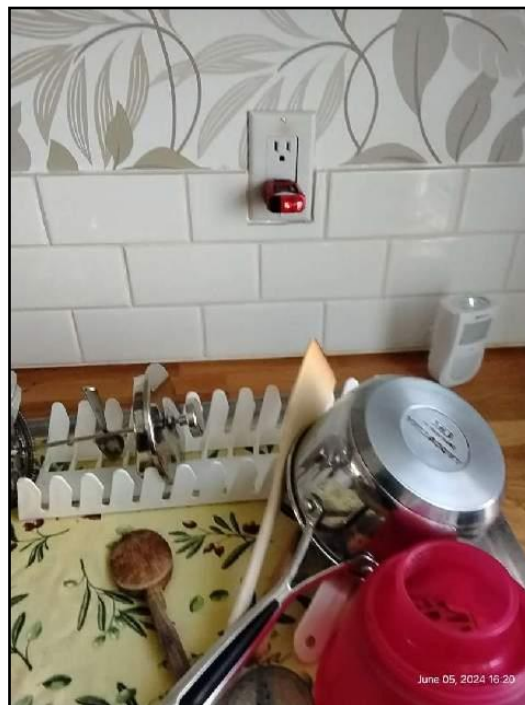
29. No GFCI/GFI (Ground Fault Circuit...

**7. Condition:** • No GFCI/GFI (Ground Fault Circuit Interrupter)

The electrical receptacles within 1.5 meters (5 feet) of the kitchen sink is not GFCI protected. GFCI installation is recommended for safety reasons if this can be achieved with the current wiring configuration. In older construction, if the wiring of the kitchen receptacles are split circuits, usually each rated for 15 Amps, this usually means that GFCI installation may not be possible, but please confirm this with a qualified electrician.itchen counters

**Implication(s):** Shock hazard

**Task:** ,Further evaluation by licensed electrical contractor to determine scope of work and cost

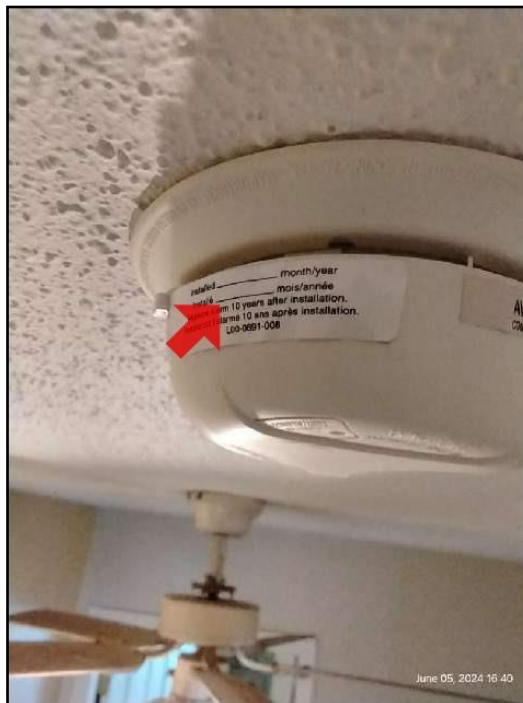
30. Missing date

8. **Condition:** • Missing/Expired

The installation of independent Carbon Monoxide (CO) detectors or combined Smoke and Carbon Monoxide (CO) detectors on all levels of a home and near sleeping areas is recommended. The provision of CO detectors was added to the safety requirements for homes built in 2012 and after. Any existing smoke detectors can simply be replaced with a combined unit. Providing electrical power for the operation of all safety devices is best rather than just battery-operated unit

**Task:** Replace

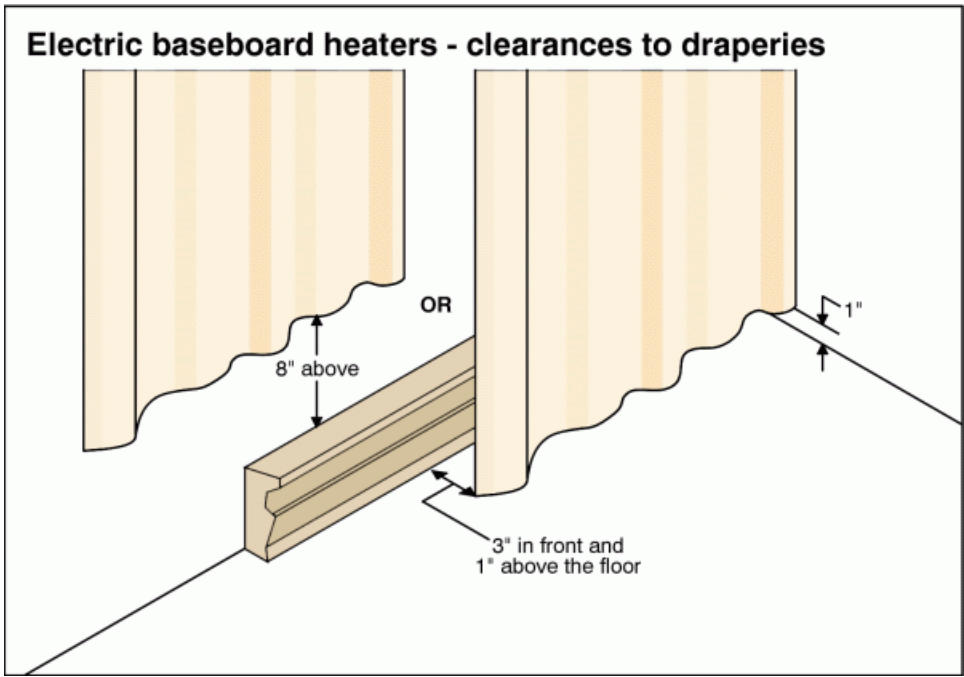
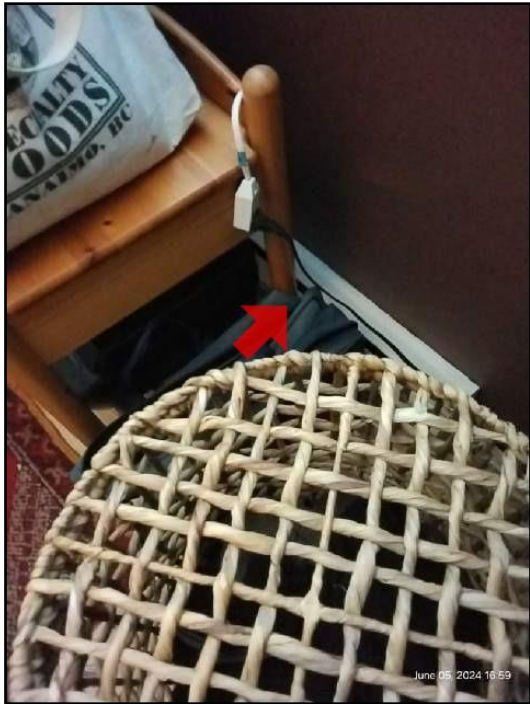
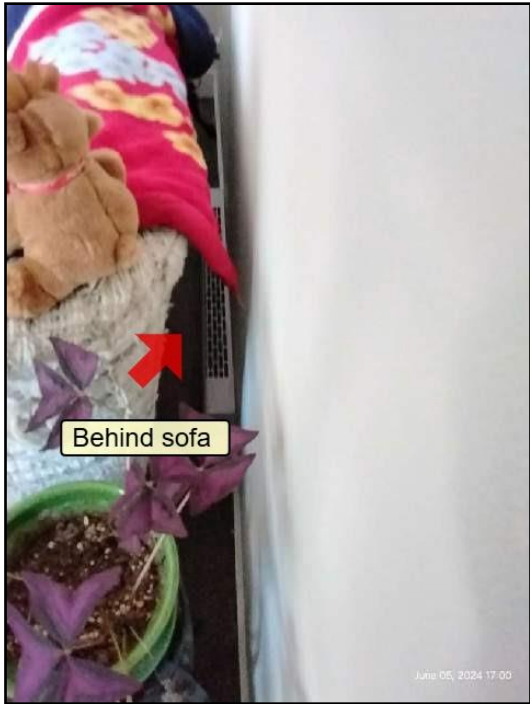
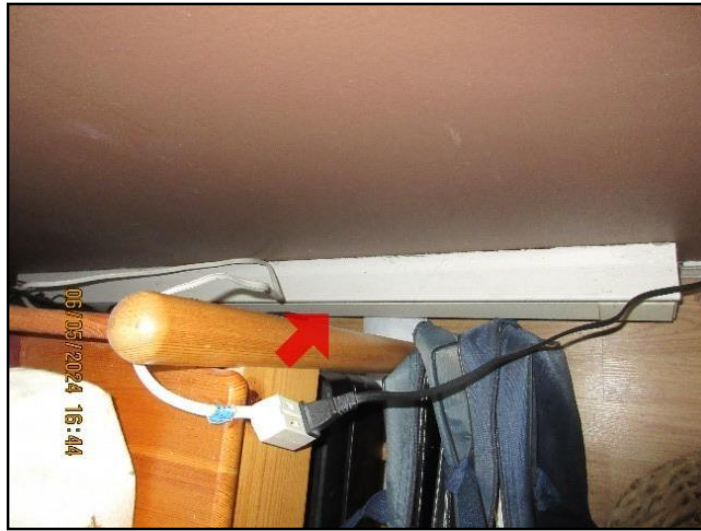
**9. Condition:** • Noted few things on baseboard heater in living room Be sure to keep all drapes, curtains, furniture, electric cords and other flammable items away from these heaters when they are on. Also be careful with small children as baseboard heaters can present a burn hazard if left accessible. If you are concerned about the safety or efficiency of these heaters, consider upgrading the system. .

**Implication(s):** Fire hazard | Reduced comfort

**Task:** Remove all the stuff from baseboard heaters

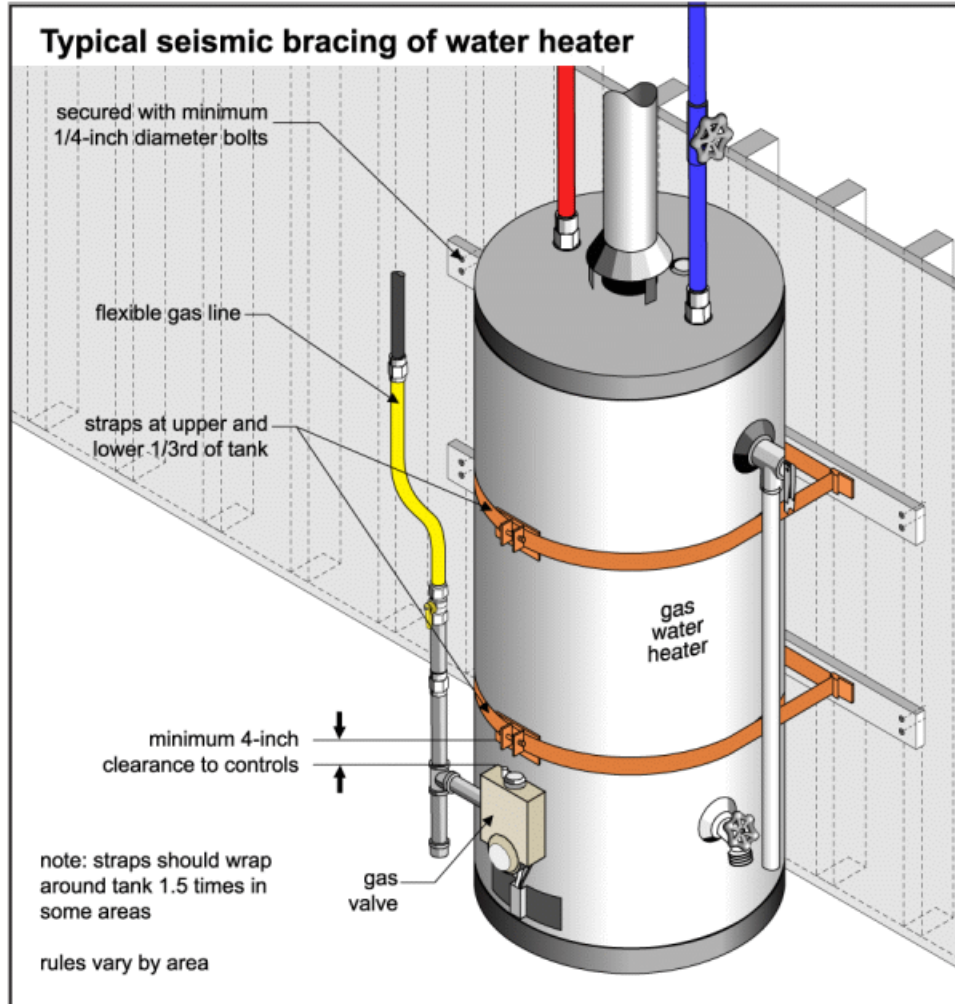
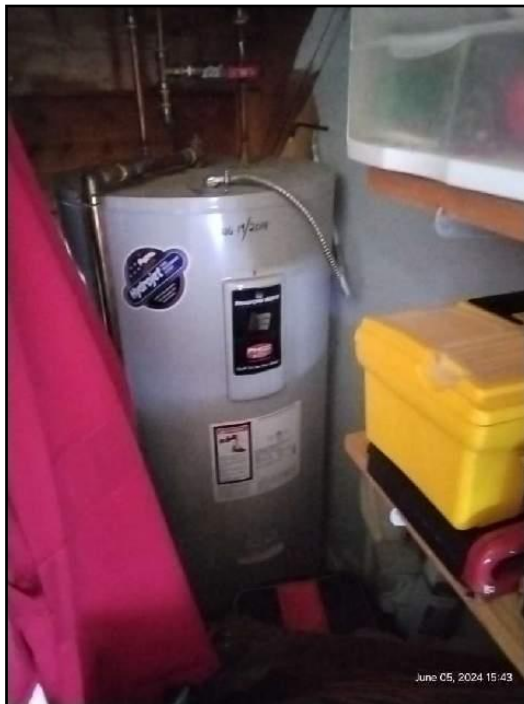
55. Bracing missing

**10. Condition:** • Bracing: There is an absence of seismic strapping retaining the hot water tank. Seismic bracing is usually required for water heaters to ensure that they do not fall over in the event of a seismic event. Although the illustrations relate to a gas water heater, electricity and water mixing in a seismic event is a similar life safety hazard.

**Task:** Install seismic bracing as per diagram by licensed plumber.

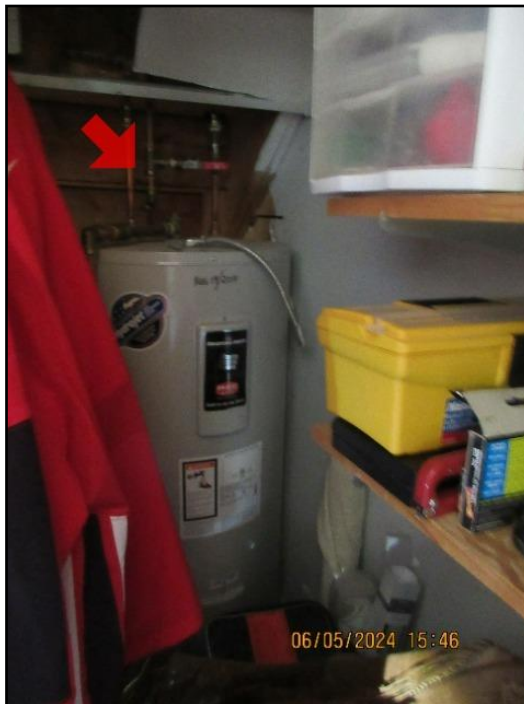
56. TERV: No expansion tank has been installed...

**Task:** A licensed plumber install an expansion tank or TERV

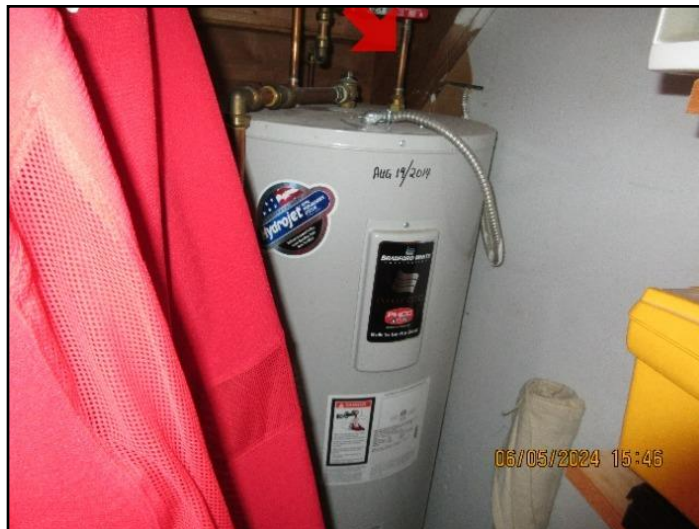
57. Copper piping

**12. Condition:** • Copper pipes generally have a life expectancy of 35 years. These pipes appear to be original to the townhome and therefore are nearing or at their expected life.

**Task:** Higher potential for leaks to develop due to their age. Check with strata regarding any replacement upgrading of the copper supply piping.

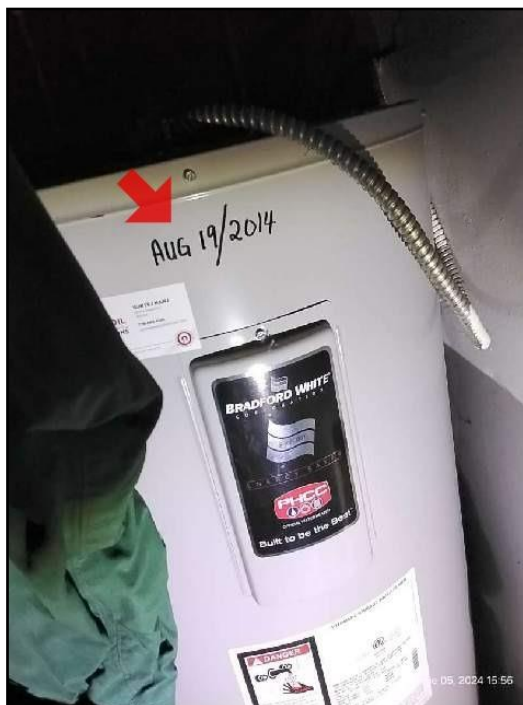
59. Near end of life expectancy

**Condition:** • Near end of life expectancy

Hot water tank is about 10 year old and life expectancy is about 8 to 10 years. One cannot predict with certainty when replacement will become necessary due to failure. However for tanks that are 10 years of age or older most insurance companies require replacement. Check with you home insurer as to their policies regarding tank age and replacement requirements. It is most likely that your insurer will require the tank to be replaced if it is 10 years old or older.

**Task:** Insurance issue ,Engage a plumber for quote (budget for replace )

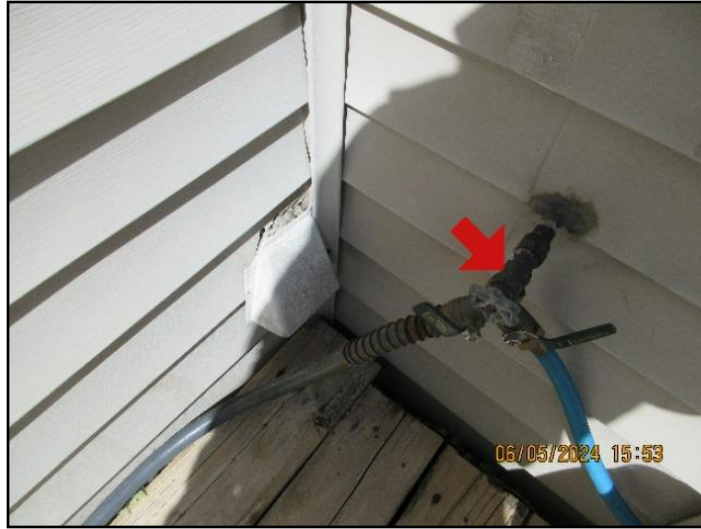
60. Not Frost Free Seasonal shut off valves nee...

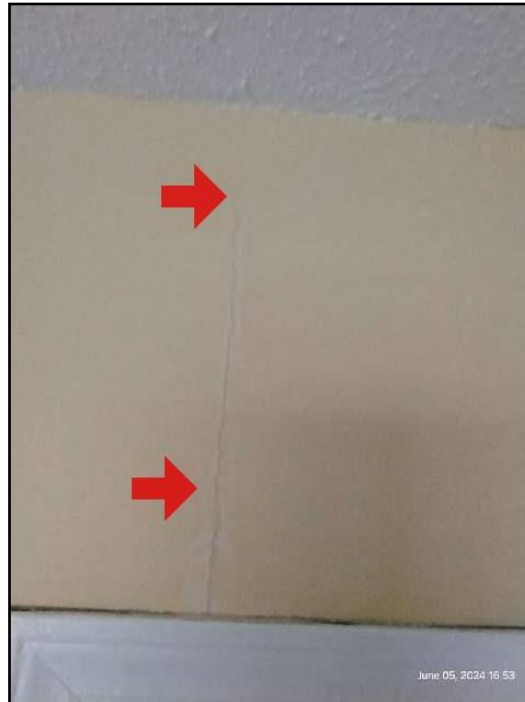
86. Crack was noted in the wall . Cracking can...

**Task:** Repair by drywaller

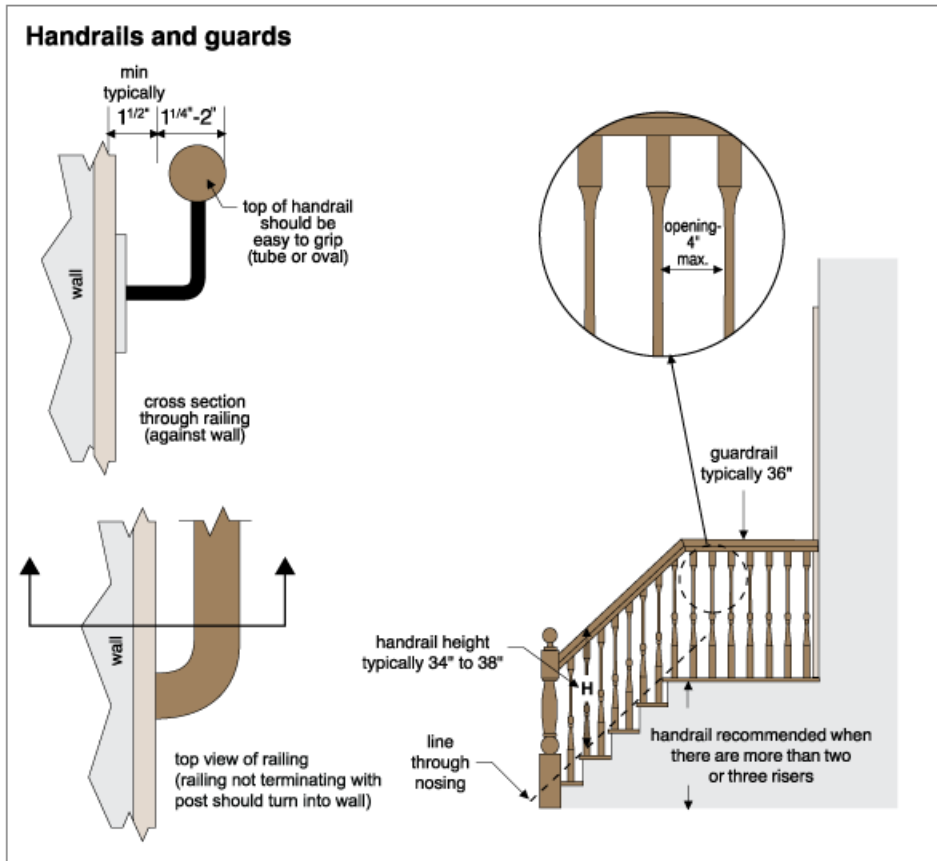
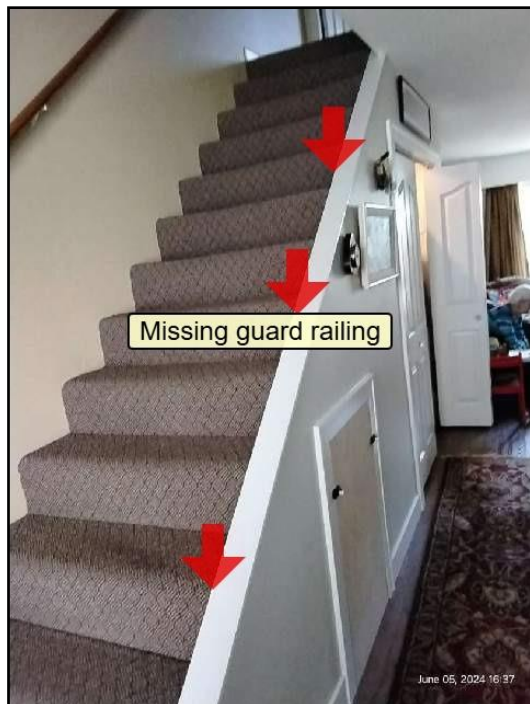
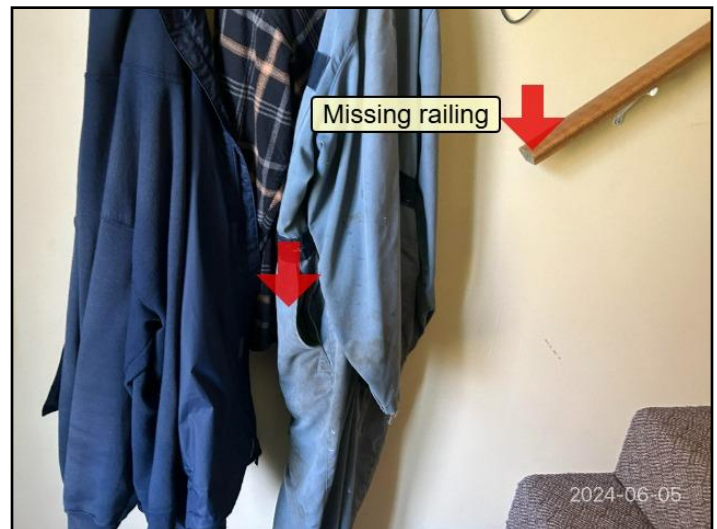
87. Missing

**Condition:** • [Missing](#)

A guardrail is needed for the interior stairs to eliminate a safety hazard, especially for children. Railings with openings no larger than 4 inches are recommended for all stairs with three or more stairs. Handrails that have returns into the walls are needed for the length of the stairs. Guardrails should have openings no larger than 4 inches and railing should be 36 inches high and strong enough to hold a falling adult. Hire a carpenter to repair and bring guardrail and handrail up to modern standards.

**Implication(s):** Fall hazard

**Task:** Repair or replace by carpenter

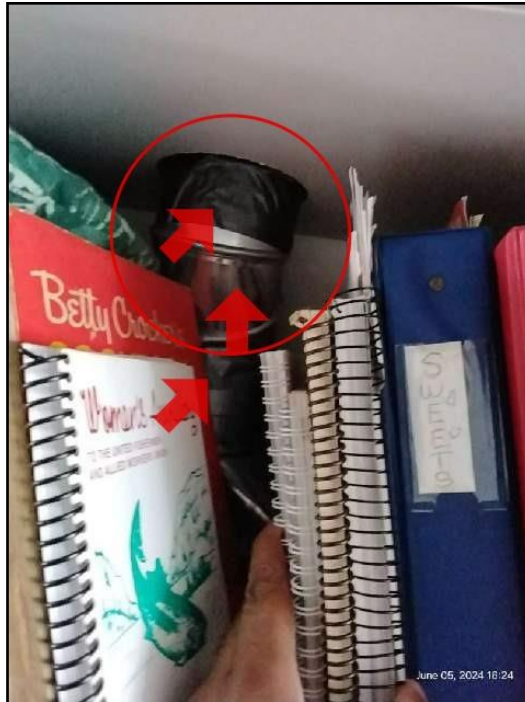
89. utility duct tape

**Task:** Repair or replace
