INSPECTION REPORT

For the Property at:
1606 ANY DRIVE
MY VILLAGE, BC

Prepared for: ABC JHON
Inspection Date: Saturday, October 1, 2022
Prepared by: Gurtej Manj

RE: Report No. 1020, v.0
1606 Any Drive
My Village, BC

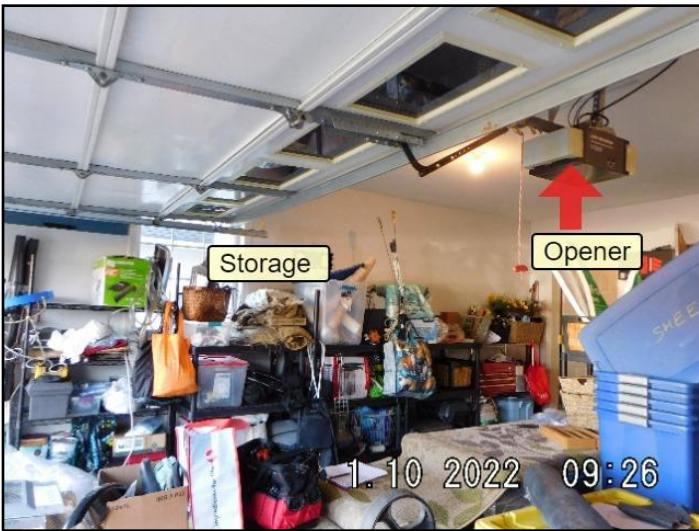
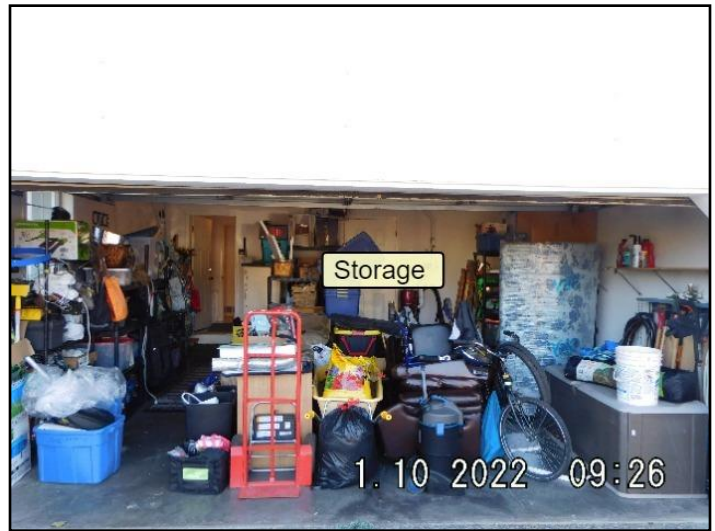
13. Storage in garage

14. Storage in garage

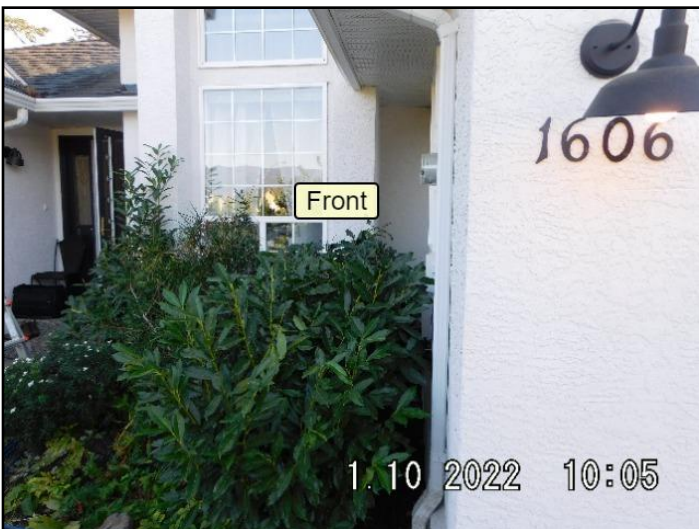
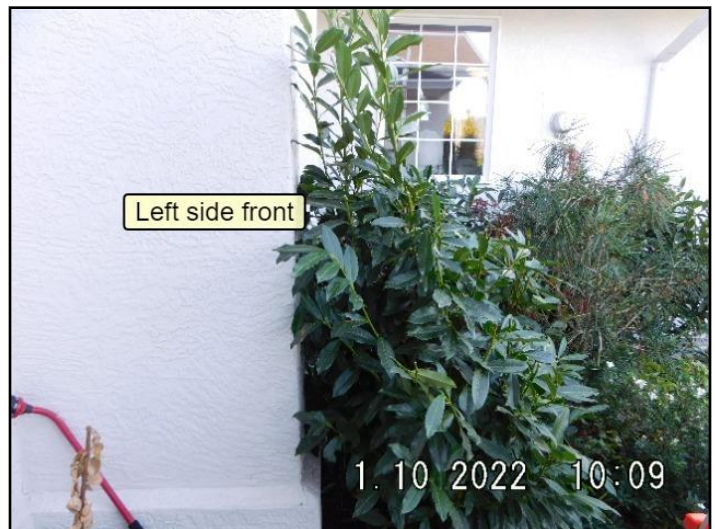
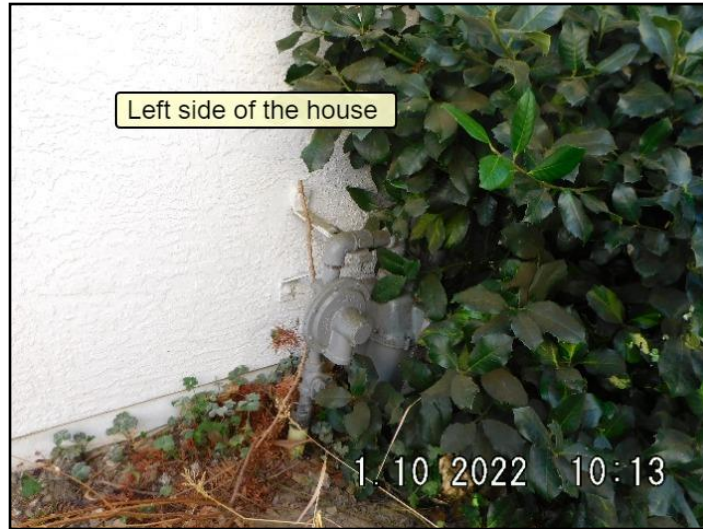
15. Vines/shrubs/trees against wall

16. Vines/shrubs/trees against wall

17. Vines/shrubs/trees against wall

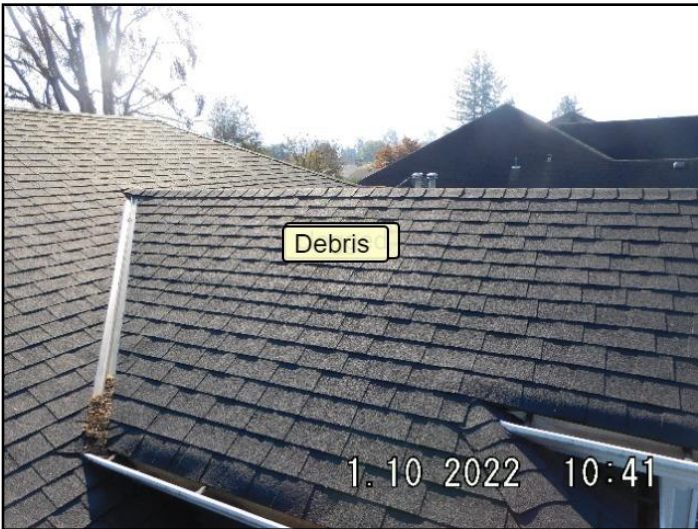
20. Clogged

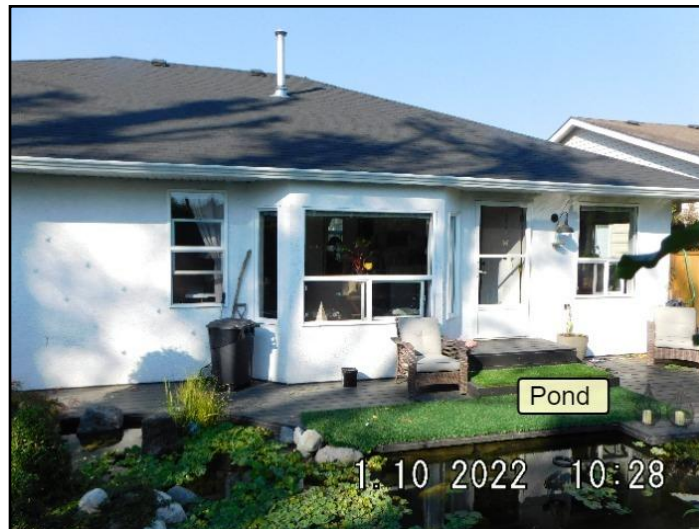
25. Pond

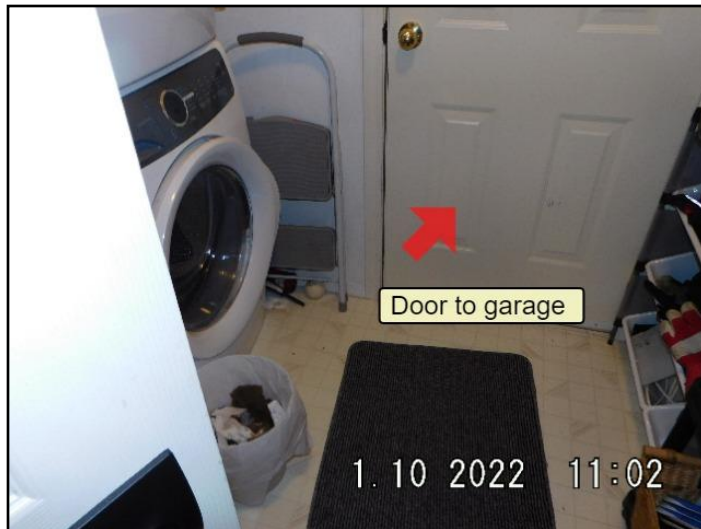
Condition: • Door from garage to main floor is not self closing , if an auto mobile in garage is running ,co fumes can enter the house

26. Door

Task: Repair by carpenter

Time: Immediately upon possession

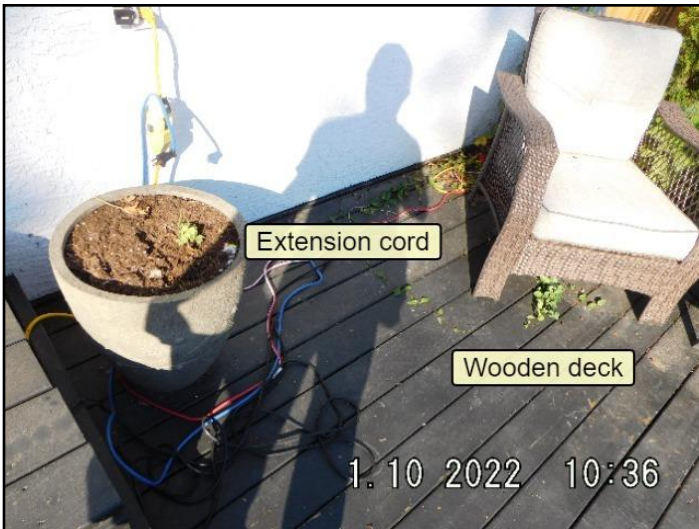
34. Wooden deck in back

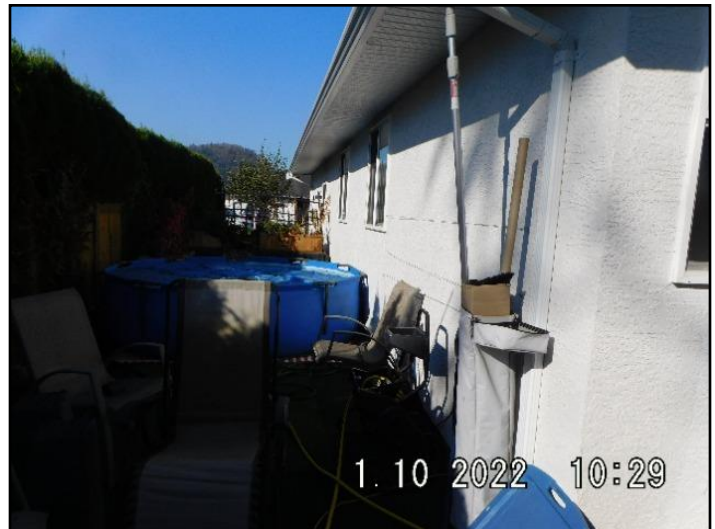
35. Water pool and storage

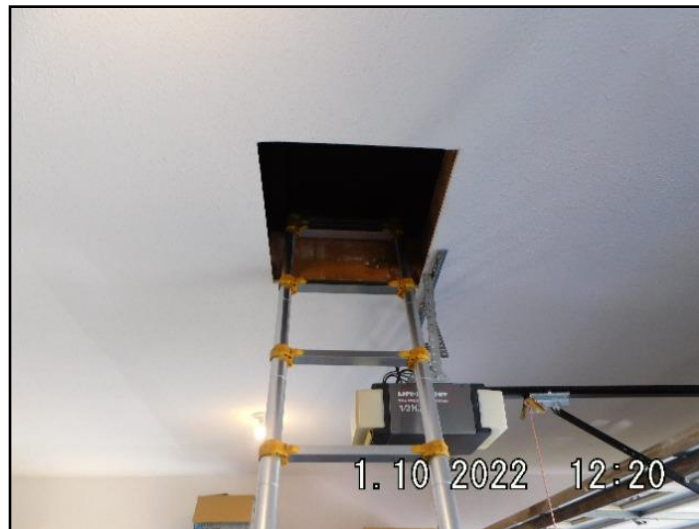
36. Entered but access was limited

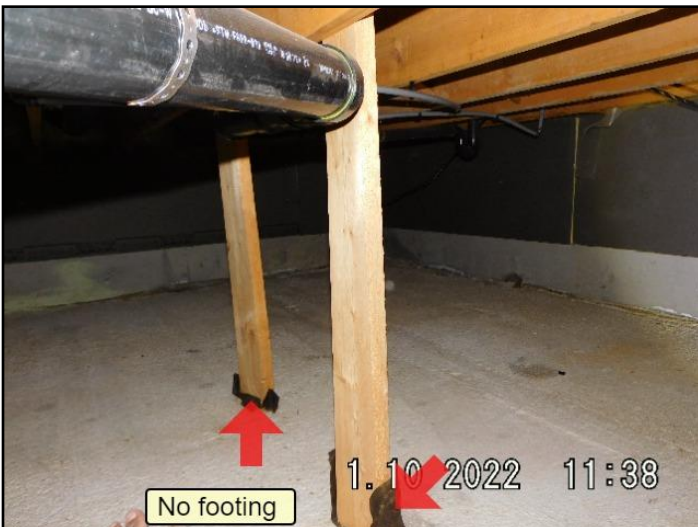
41. Notches or holes

Task: Further evaluation by structural specialist to determine scope of work and cost

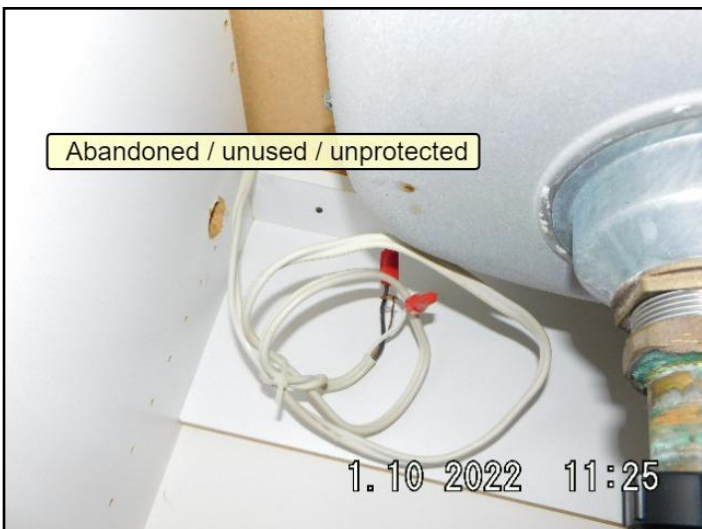
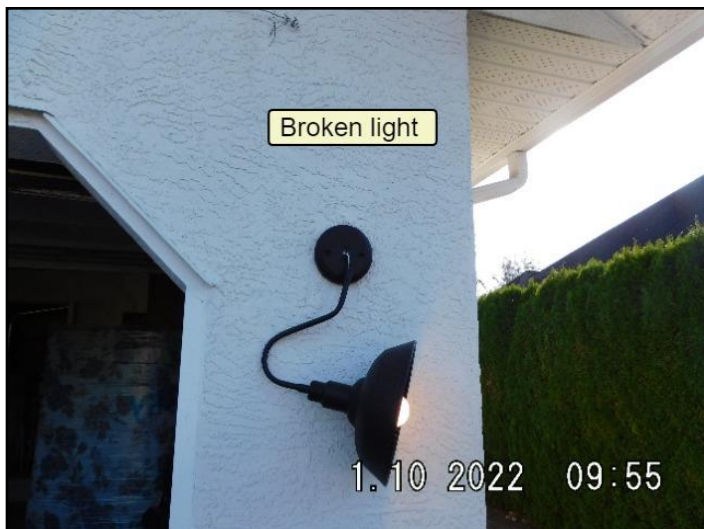
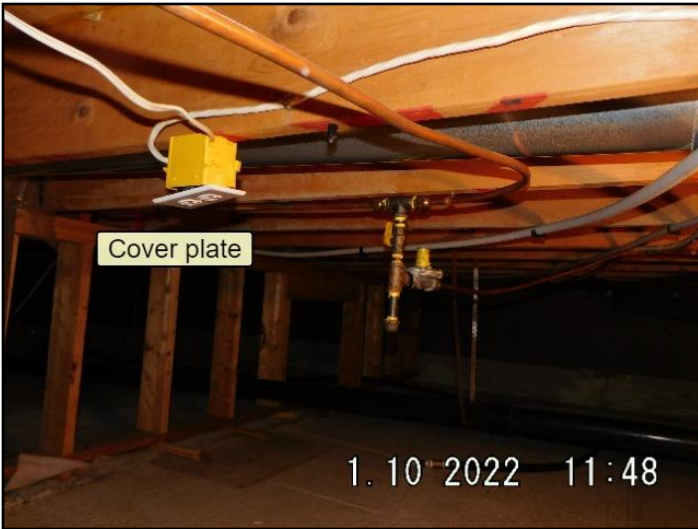
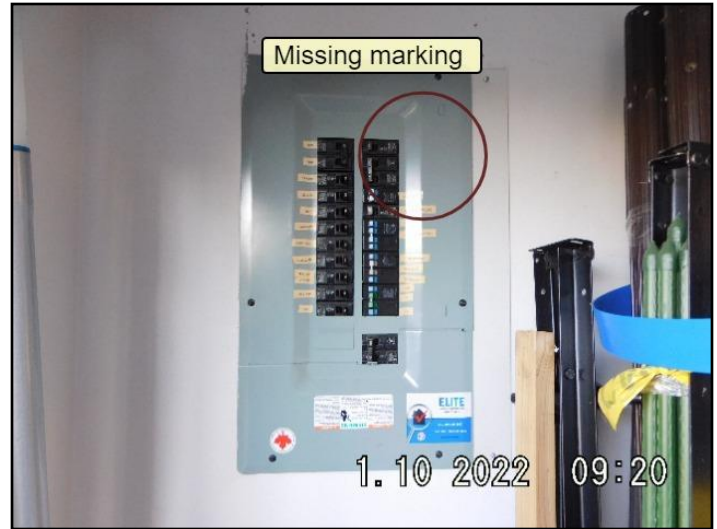
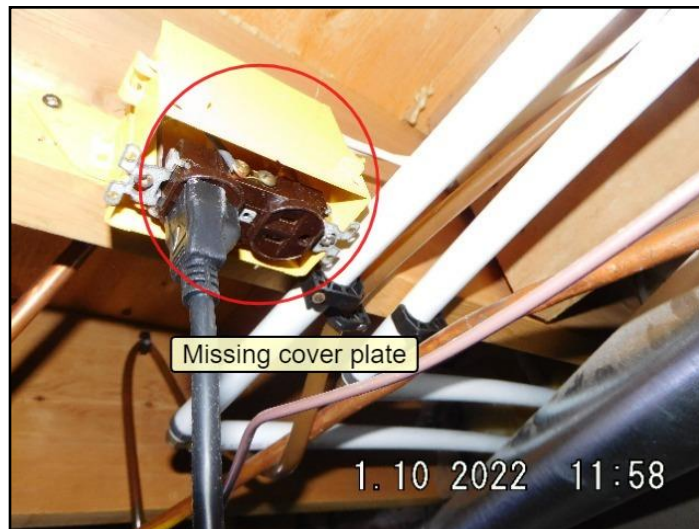
13. Condition: • Abandoned / unused / unprotected wire under the kitchen sink and missing marking on panel cover . Right side Front of the garage light is hanging too need to be fix cover plate in crawl space .

Implication(s): Shock / Fire hazard

Task: Consult with an electrician for repair, Safety Concern

Time: Immediately upon possession

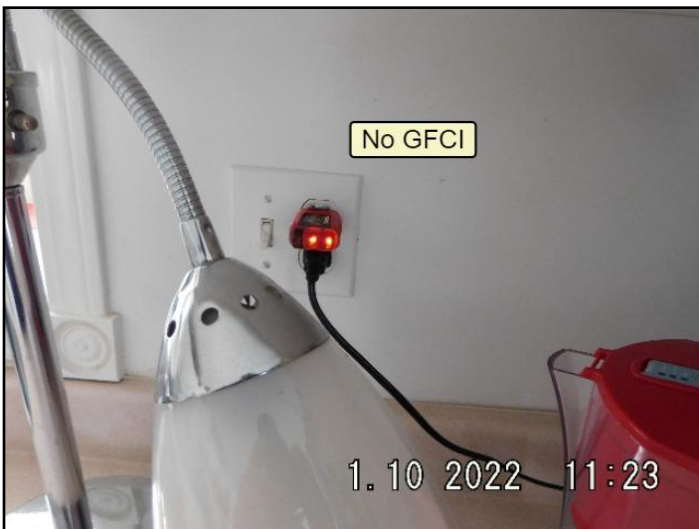
14. Condition: • Kitchen counters

57. Kitchen counters

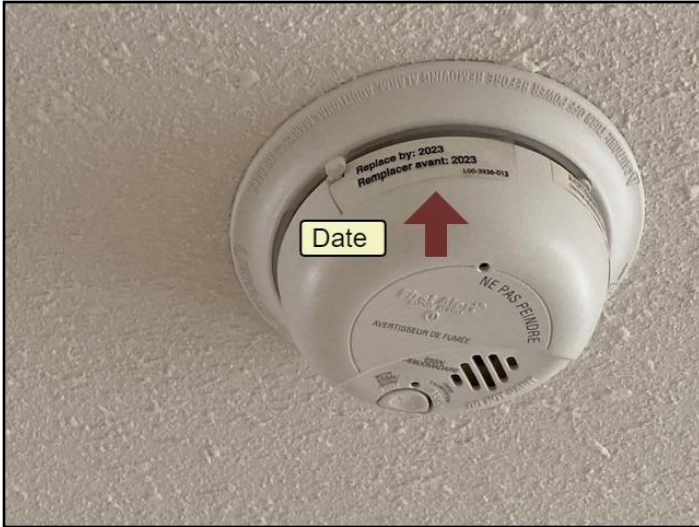
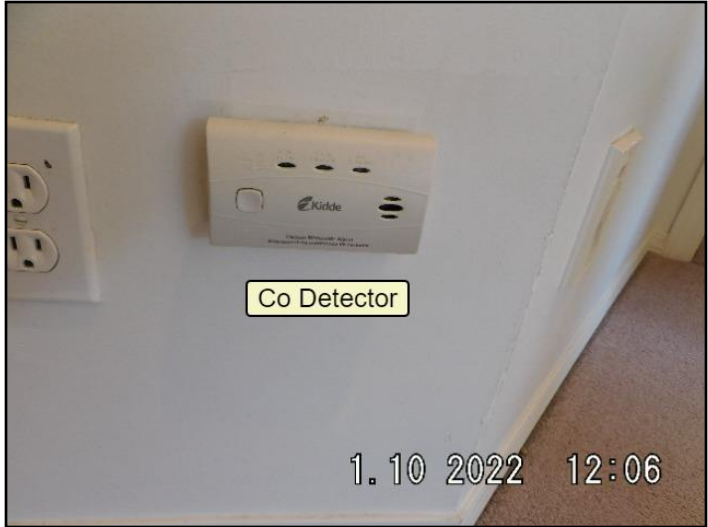
15. Condition: • Noted smoke detector going to expires in 2023 The installation of independent Carbon Monoxide (CO) detectors or combined Smoke and Carbon Monoxide (CO) detectors on all levels of a home and near sleeping areas is recommended. The provision of CO detectors was added to the safety requirements for homes built in 2012 and after. Any existing smoke detectors can simply be replaced with a combined unit. Providing electrical power for the operation of all safety devices is best rather than battery operated units.

Implication(s): Fire and life safety hazard

59. Smoke detector

60. co detector

Location: Hallway / living space
Task: provide for improved safety
Time: Immediately upon possession

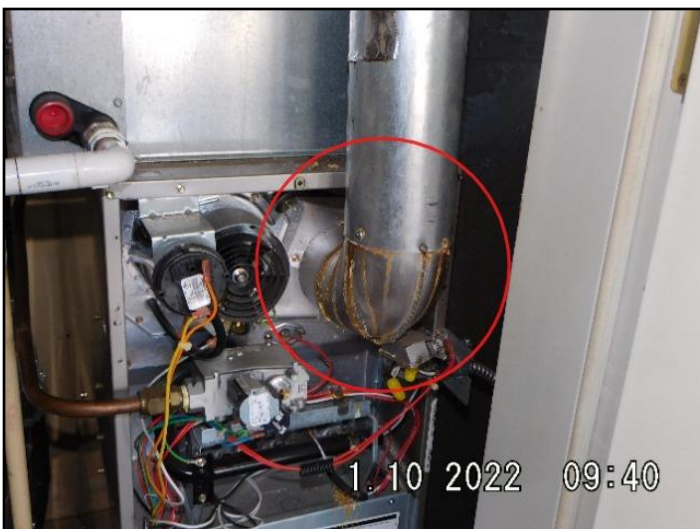
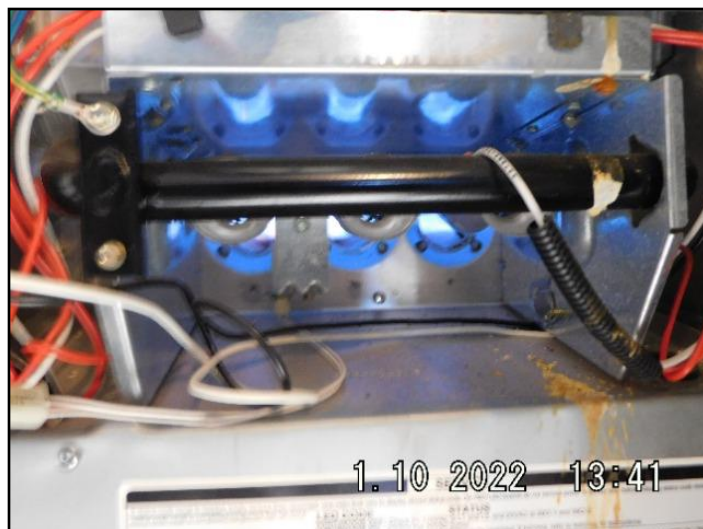
19. Condition: • Service Furnace

This 13 year old furnace . It was found to be operational however it should be further reviewed during a standard service. The system should be cleaned, serviced and adjusted. Regular servicing and maintenance is needed for safe reliable operation, even more so as equipment ages.

70. Service Furnace

71. Service Furnace

Task: Service by a HVAC technician yearly

Time: : Prior to the heating season

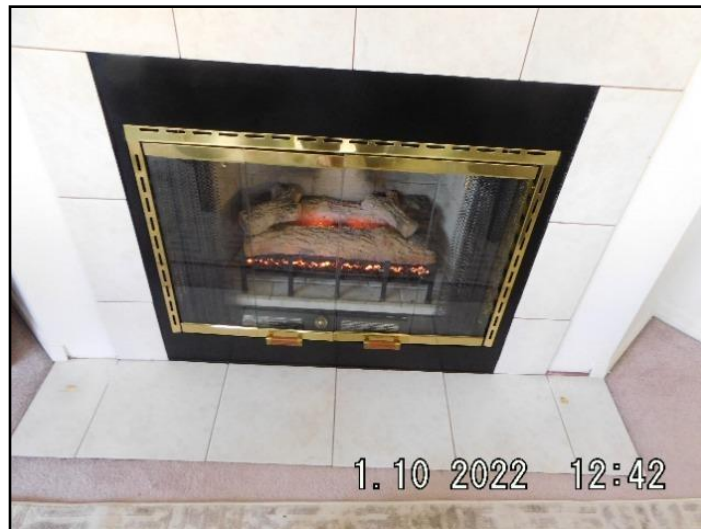
22. Condition: • Fireplace was operational at the time of inspection .

74. Operational fireplace

Task: service the fire place by qualified contractor

Time: upon possession

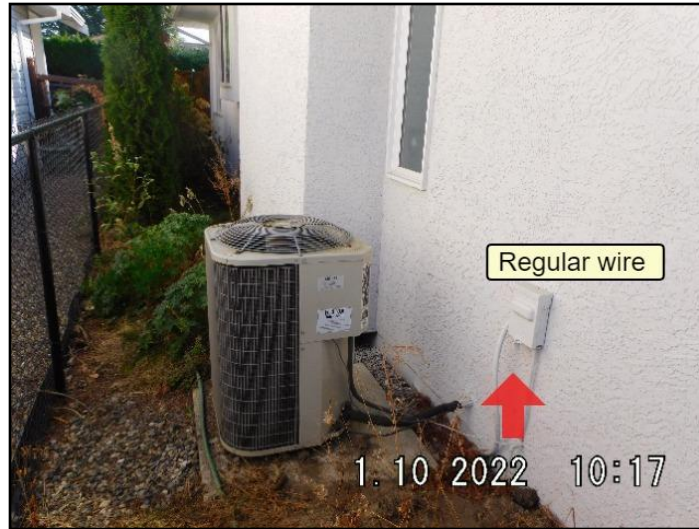
23. Condition: • Wire to A/C unit is regular and paint on it .should be protected wire

Task: Repair by certified electrician

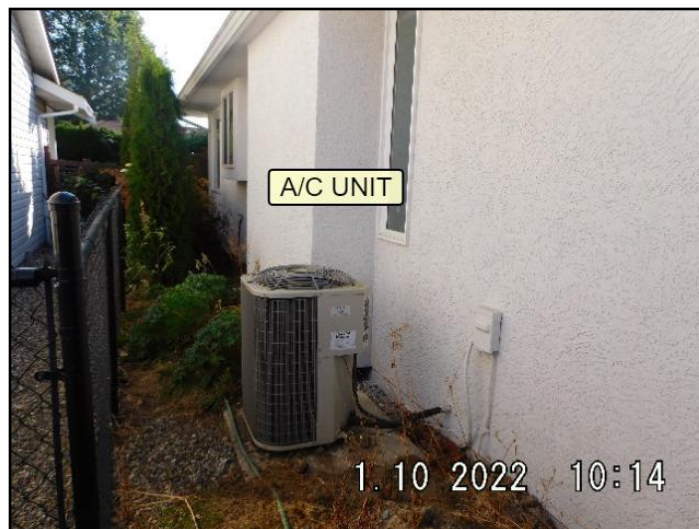
24. Condition: • [Near end of life expectancy](#)

Implication(s): Equipment failure | Reduced comfort

77. Near end of life expectancy

Task: Service by a HVAC technician

Time: upon possession

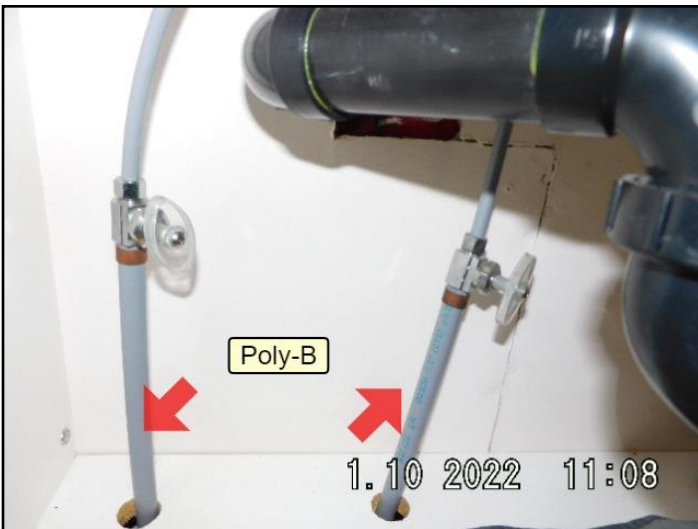
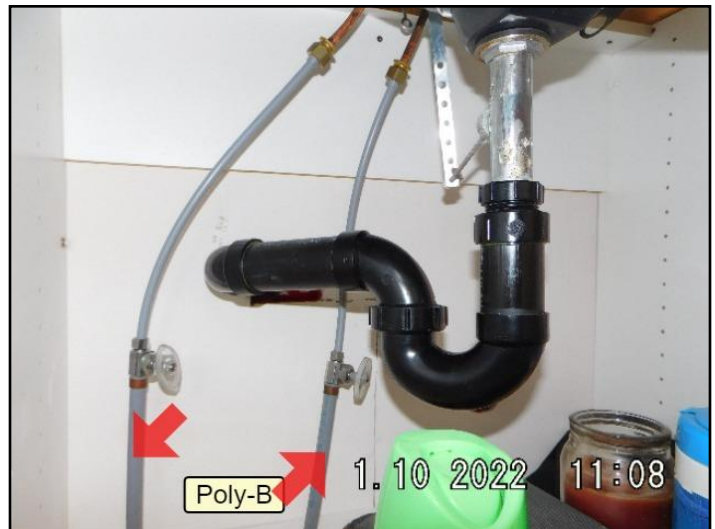
85. POLY-B

86. Poly-B

26. Condition: • poly B:

This home is plumbed, in part or in whole, with Poly B (Polybutylene) piping. Poly B was manufactured and installed in homes in North America from the late 70's to the mid 90's. Many homes have experienced no problems; however, Poly B has a higher-than-normal failure rate. Plastic fittings were the most problematic. Canadian installers used primarily copper and brass fittings and elbows, which alleviated many of the problems. The visible Poly B in this home uses copper or brass fittings, and no leaks were noted at the time of inspection. Contributing factors for failure are water pressure in excess of 60 PSI, hot water temperatures of over 130F, high chlorine levels, when used in a hot water circulation loop, it may corrode, and it should never be connected directly to a hot water heater, nor exposed to sunlight. Your insurer may want to know if the fittings are copper. Investigate your insurers' position on homes with Poly B

Implication(s): : Chance of water damage to structure, finishes and contents | Leakage

Task: Discuss with insurance company. Consult a lic. plumber regarding the condition of the piping.

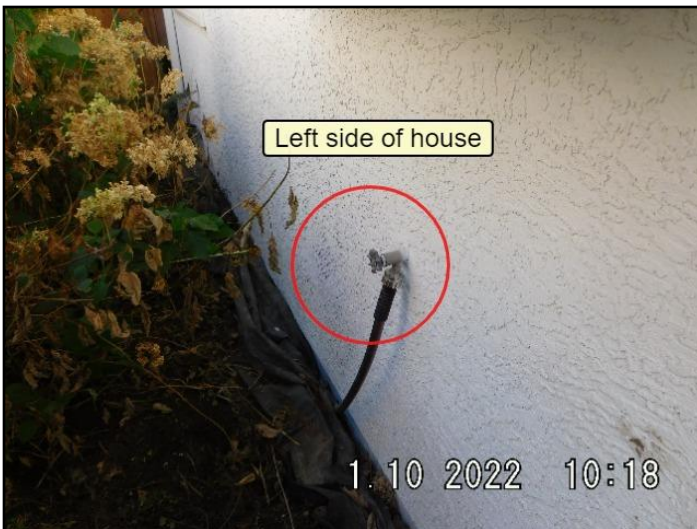
96.

31. Condition: • Not Frost free

Implication(s): : Chance of water damage to structure, finishes and contents

Task: Replace with frost free type - or locate shut off valve and drain before winter to prevent freezing.

Time: Before winter

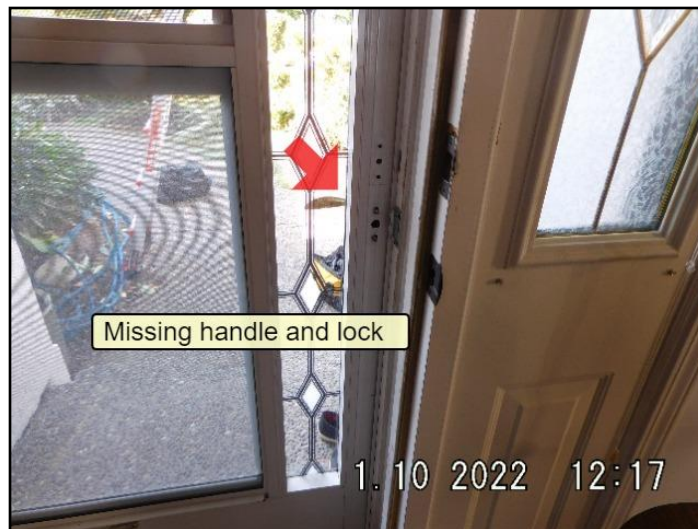
109. Storm door

32. Condition: • Missing hardware on the exterior front storm door can not able to open or close and lock the door

Task: Repair

Time: Regular maintenance Immediately upon possession

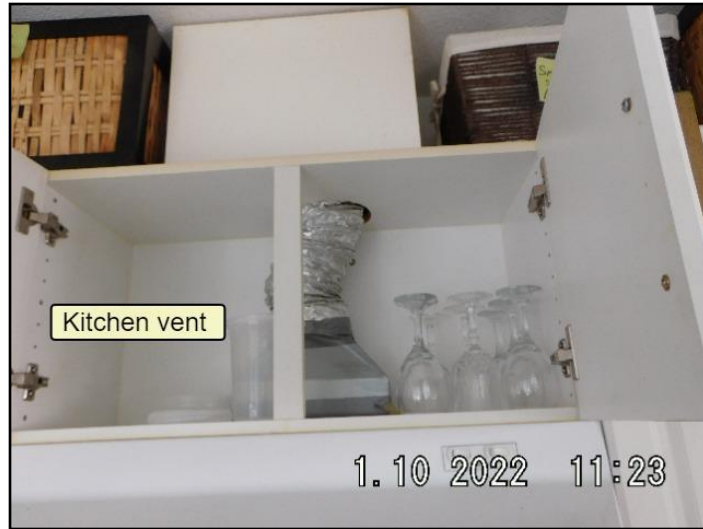
110.

34. Condition: • Range hood discharges to the soffits and The flexible metal type of vent connector has the advantage of being quick and easy to install. The disadvantages are that it restricts the air flow within the vent and the interior ridges can trap grease (oil) leading to a potential fire hazard and air exhausted through the soffit will likely be sucked back into the attic through the soffit vents . The condition is mitigated by the short run before the vent connects to the ceiling.

Implication(s): Fire and life safety hazard

Time: upon possession

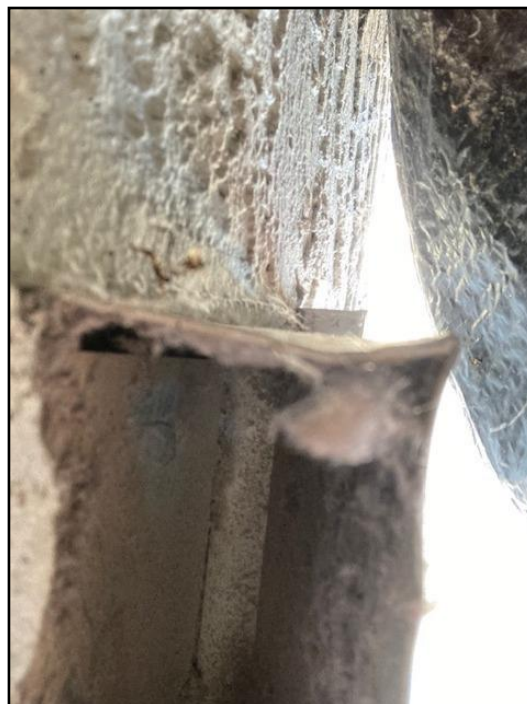
111. Dryer vent

35. Condition: • Vent is clogged with lint restricts the air flow within the vent and leading to a potential fire hazard.

Implication(s): : Equipment ineffective | Fire hazard

Task: Clean the vent

Time: upon possession
