# Your Inspection Report

10-110000 45 AVE  
My Village, BC

Wednesday, June 5, 2024

RE: Report No. 1073, v.0  
10-110000 45 AVE  
My Village, BC

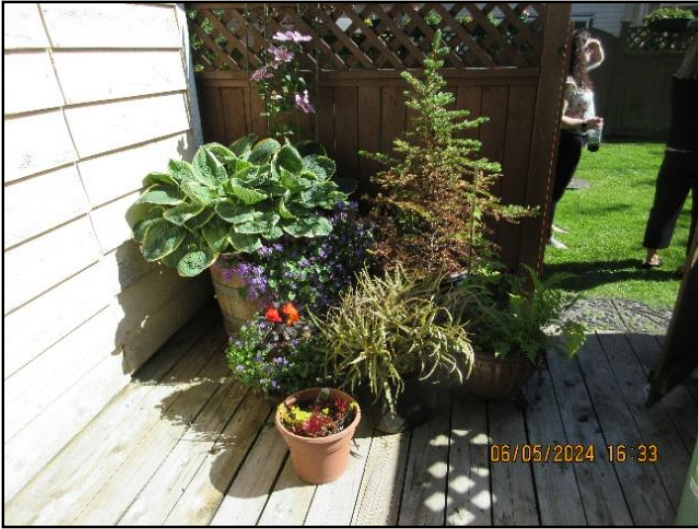
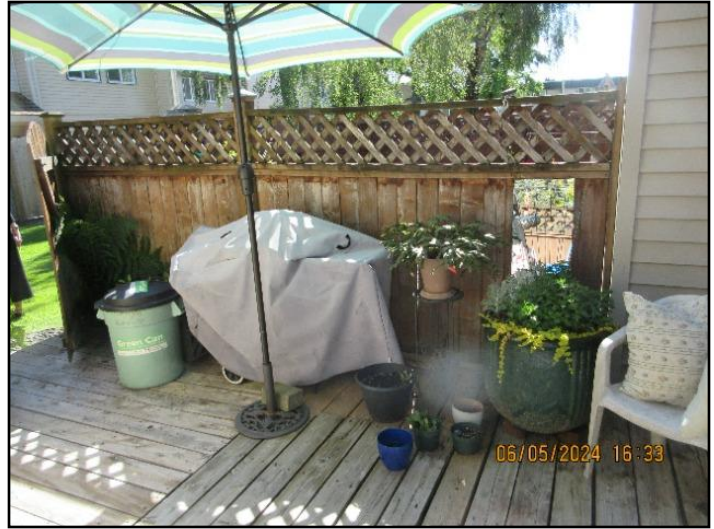
11. Storage on patio

12. Storage on patio

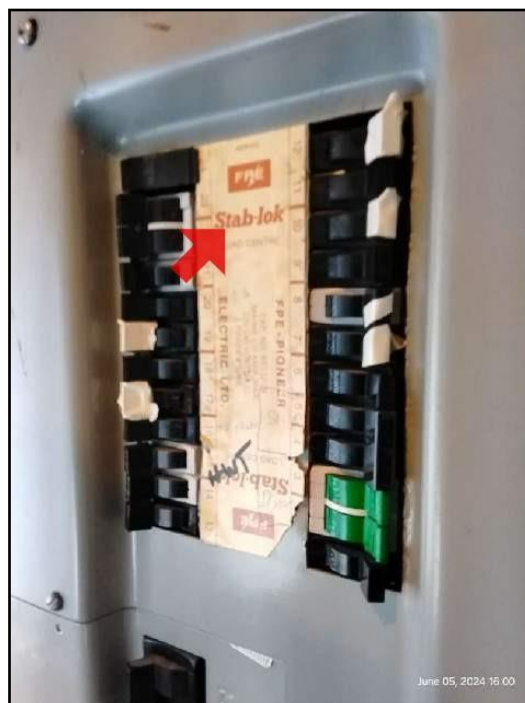
19. FPE Stab-Lok

- FPE Stab-Lok

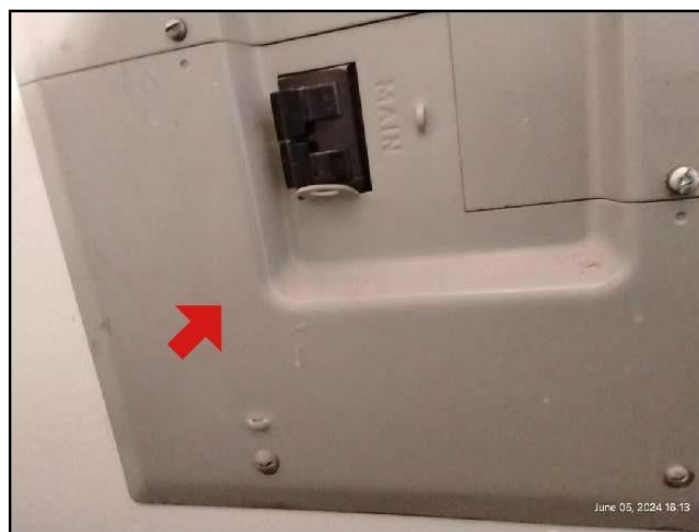
- Not safe to remove

**27. Not safe to remove**

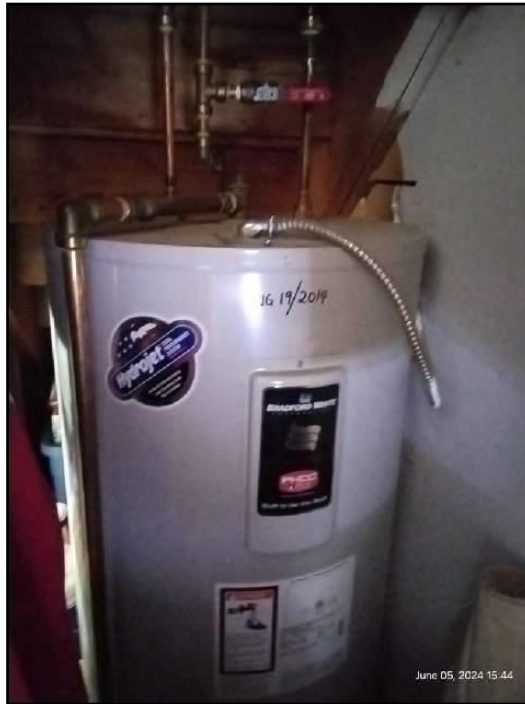
45. Conventional

**Condition:** • Near end of life expectancy

Hot water tank is about 10 year old and life expectancy is about 8 to 10 years. One cannot predict with certainty when replacement will become necessary due to failure. However for tanks that are 10 years of age or older most insurance companies require replacement. Check with you home insurer as to their policies regarding tank age and replacement requirements. It is most likely that your insurer will require the tank to be replaced if it is 10 years old or older.

**Task:** Insurance issue ,Engage a plumber for quote (budget for replace )

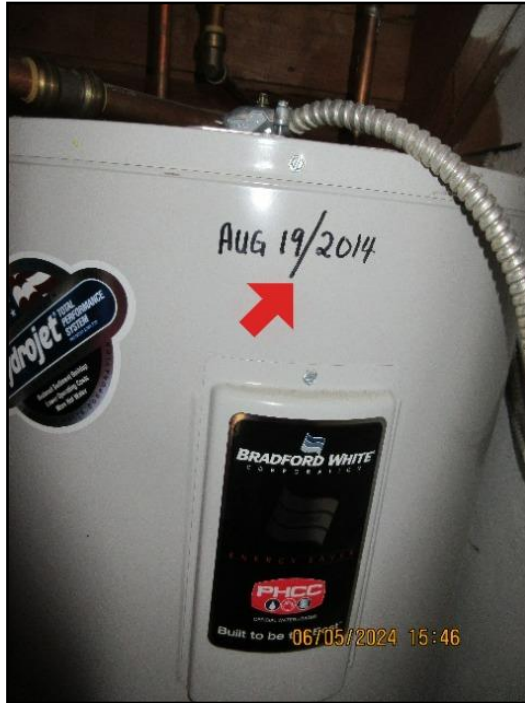
50. 10 years

Got info from tank installed in 2014

**Water heater typical life expectancy:** • 8 to 10 years

**14. Condition:** • Near end of life expectancy

Hot water tank is about 10 year old and life expectancy is about 8 to 10 years. One cannot predict with certainty when replacement will become necessary due to failure. However for tanks that are 10 years of age or older most insurance companies require replacement. Check with you home insurer as to their policies regarding tank age and replacement requirements. It is most likely that your insurer will require the tank to be replaced if it is 10 years old or older.

**Task:** Insurance issue ,Engage a plumber for quote (budget for replace )
